INSPECTION CONNECTION, INC.

ADDRESS: 4 ELM

SAMPLE INSPECTION REPORT

4 ELM, SAMPLE, IL

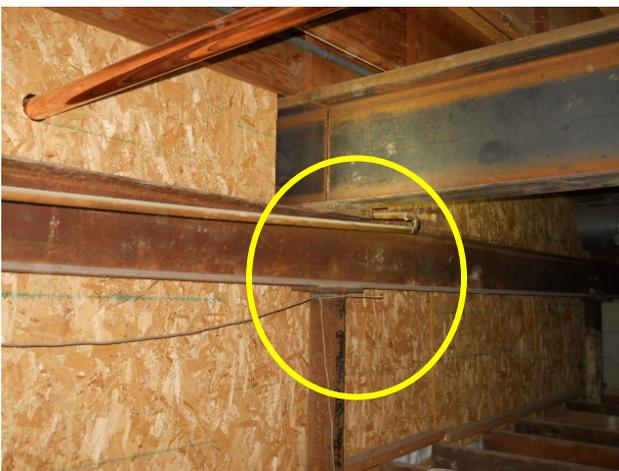
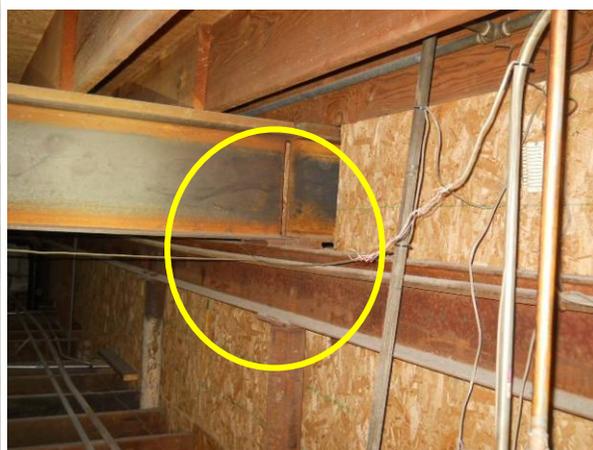
- No major structural problems observed.
- The main beams holding up the floor to the units above you are not fastened to the support beams beneath. And the support beam beneath that is not fastened to the steel columns supporting them. Floor joists are not fastened to beams. These details will be important in the event of a catastrophic occurrence such as an earthquake or tornado. Consult a structural professional to correct these details.

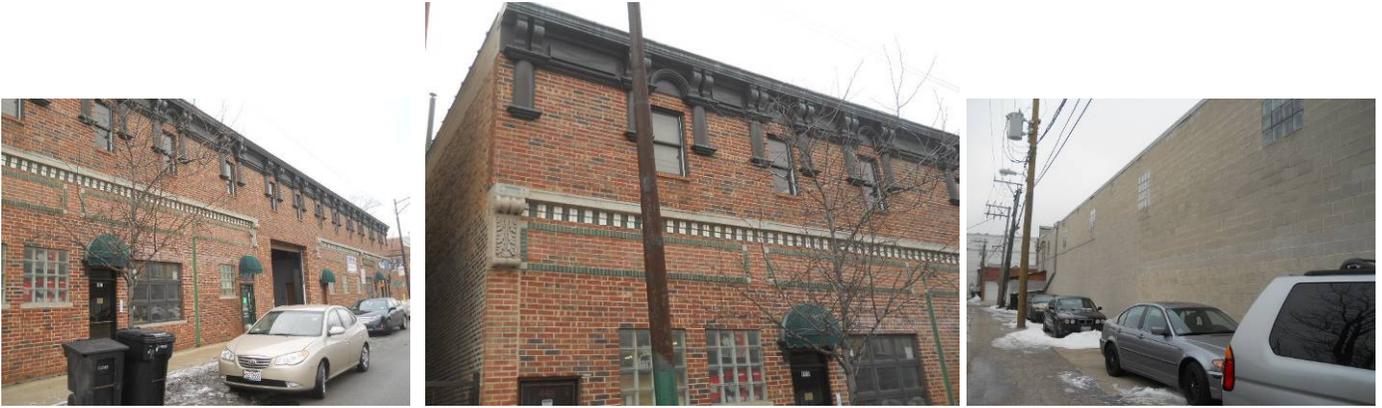
- There is white paint/graffiti on the north overhead door.
- The exterior brick in front and the CMU at the back alley are satisfactory.

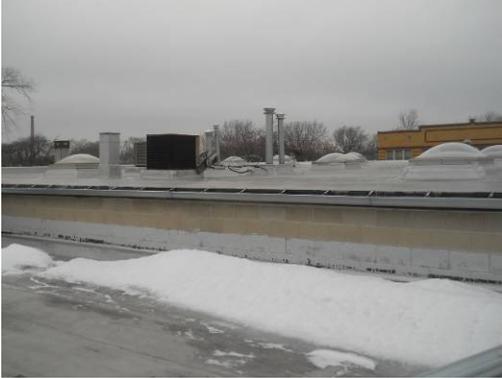
- Many areas of the interior steel roof sheathing are rusted. The roof looked newer and these are probably from old roof leaks.
- This building has two different roof systems. There is a raised roof along the north side of the building which is above the second-floor apartment units. And there is a second lower roof area to the south which is above the warehouse portions of the building

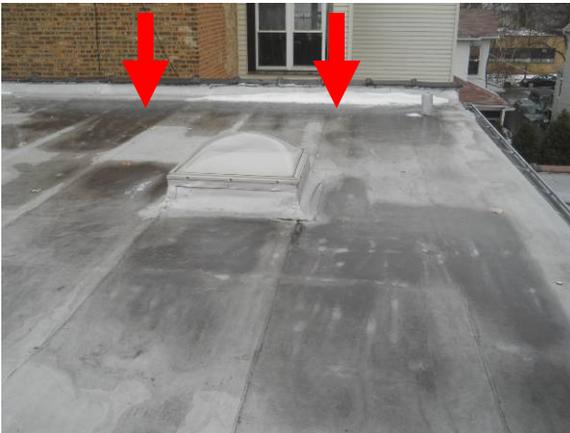
- There is ponding at the upper east roof which had about an inch and a half of ice. This ponding will accelerate roof deterioration.

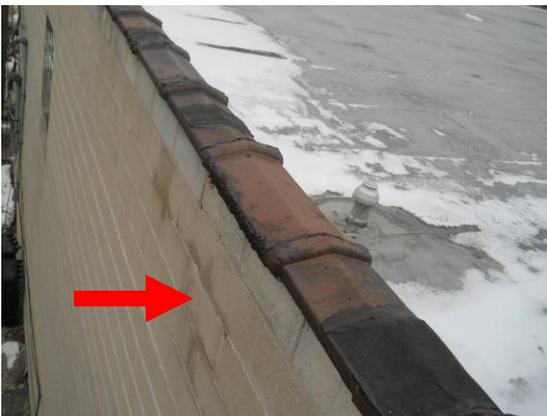
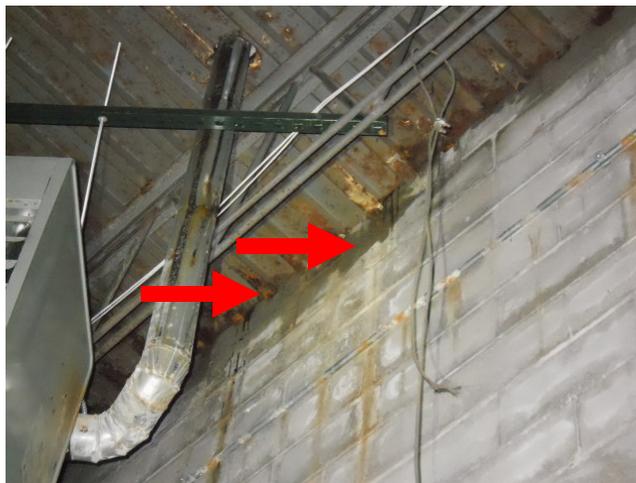
- There is a roof and/or parapet wall leak at the lower roof east side at the warehouse section of the building. A licensed roofing professional should address this.

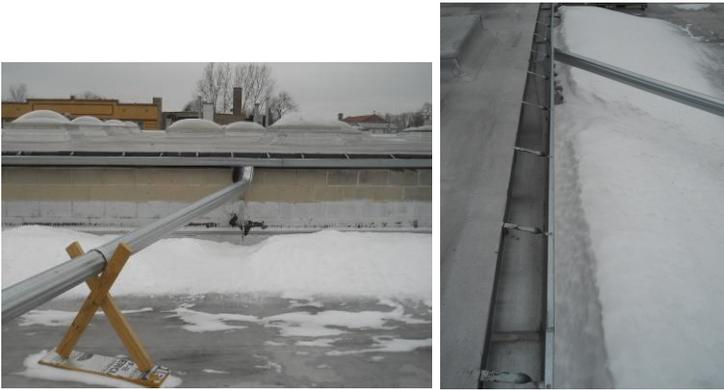
- The south lower roof is sloped to the north, and drains through roof drains. This area above your unit was all snow and ice covered and was not viewable when I was on the roof.

Heavy snow and ice at N. side of lower roof

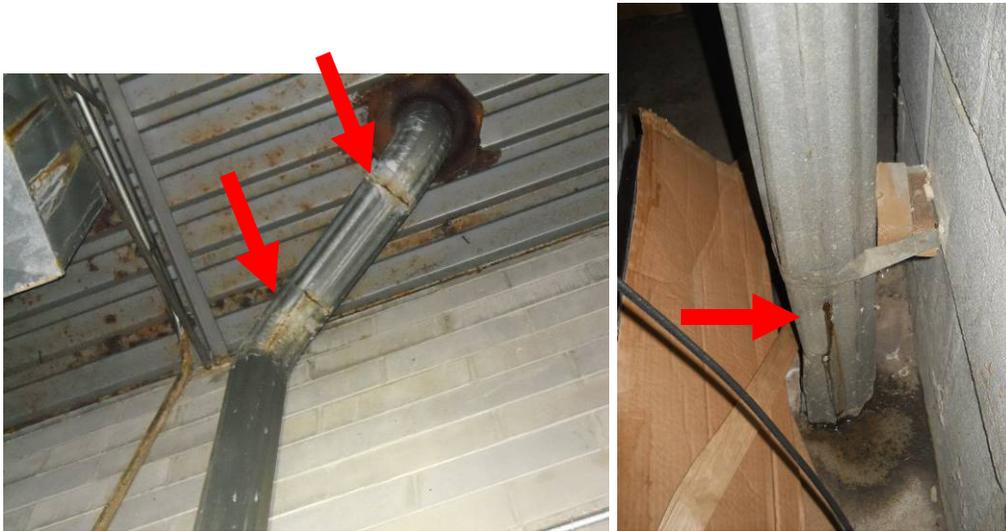
- The roof drain for the east half of the lower back roof runs to a downspout that drains in the middle of your back warehouse. It is critical that this drain never be blocked. Because of snow and ice on the roof I could not see what this roof drain looked like or whether it was protected with grates. Note: the downspout has a small hole in it near the warehouse floor and it is leaking. It also looks like there have been leaks at the downspout connections at the ceiling. Have this repaired.

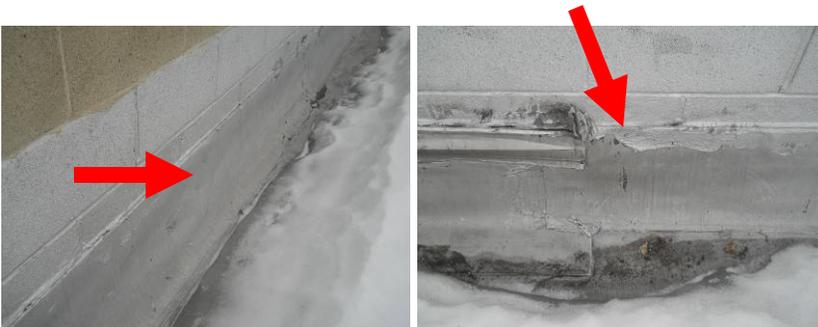
- The lower roof on the east side where it meets the CMU wall is not mechanically attached with the termination bar. This will eventually pull away from the wall and leak. Have a licensed roofing professional correct this.

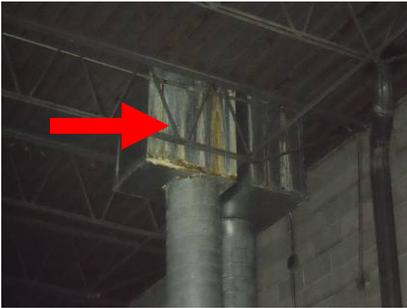
- There had been a roof leak near the rooftop HVAC system. I cannot tell if this is an old leak or not. Nothing was dripping during the inspection.

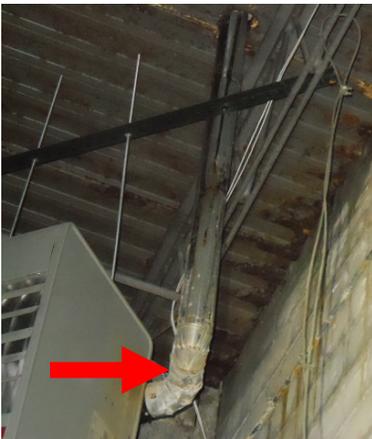
- There are two ceiling mounted space heaters. The one at the east side was operating during the inspection. The one near the front has been shut down and the gas is off. Both had excessive moisture staining at the vent connections which suggests poor drafting. Both need servicing by a licensed HVAC professional.

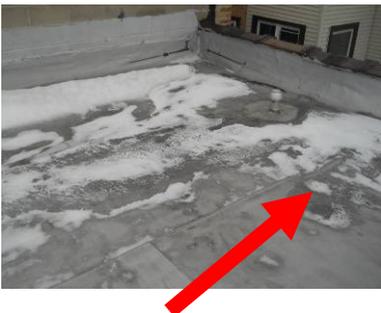
- Note: when I was on the roof I did not see the vent termination for the east space heater. There was a roof vent in this area but this cannot be used as a gas appliance vent termination.

Area where space heater should be vented???

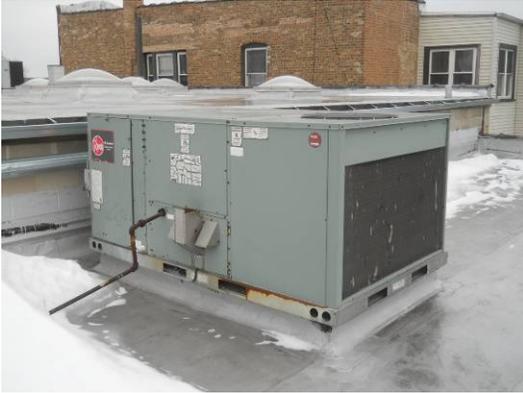
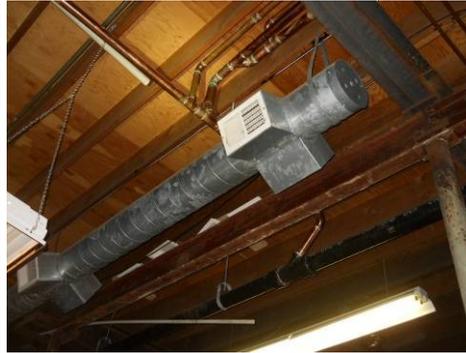
- There is a combo heating/air-conditioning unit on the roof (Age: 2001 – 225K BTU's). The gas to this was off and it is too cold test air-conditioning. *It looks like this unit is intended to condition the middle north section of your property.* A licensed HVAC pro needs make sure this is in good working order. I did not dismantle this to see the condition of the interior components such as the heat exchanger, air-conditioning compressor, and cooling coils. You will have to get with your architect and HVAC contractor to see if this is going to be adequate for your HVAC needs.

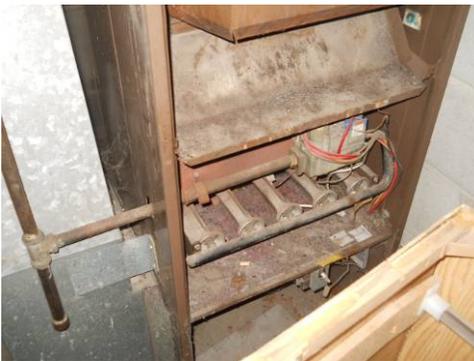
- There is a furnace which is supposed to condition the northeast rooms of the property in a closet next to the northeast office area. This furnace is very old (1987 – 125K BTU's) and badly deteriorated with an excessively rusted heat exchanger. It needs replacement. There is no air-conditioning system hooked up to this. It is also improperly vented into the ceiling with a single walled vent system and the vent termination outside looks damaged. Consult a licensed HVAC professional to see if the rooftop HVAC unit can adequately heat and cool all these areas that you will need conditioned. If you go with one HVAC system you will need to reconfigure duct work.

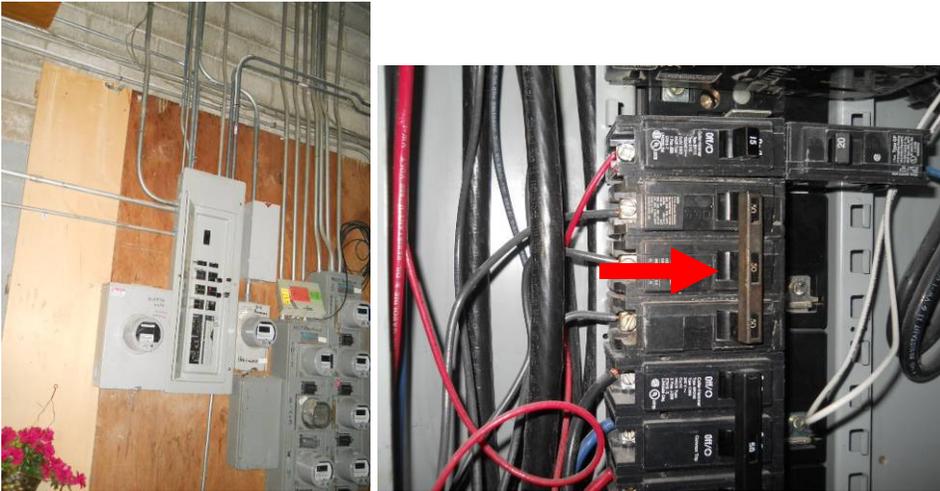
- There are many junction boxes with exposed wires above the ceiling at the northeast section of the property.
- The main panel for this property is located at the southeast corner of the warehouse. There are multiple issues of improper wiring with several grossly under wired circuit breakers (12 AWG with 50 amp). All open knockouts in the panel should be covered. Consult a licensed electrician.

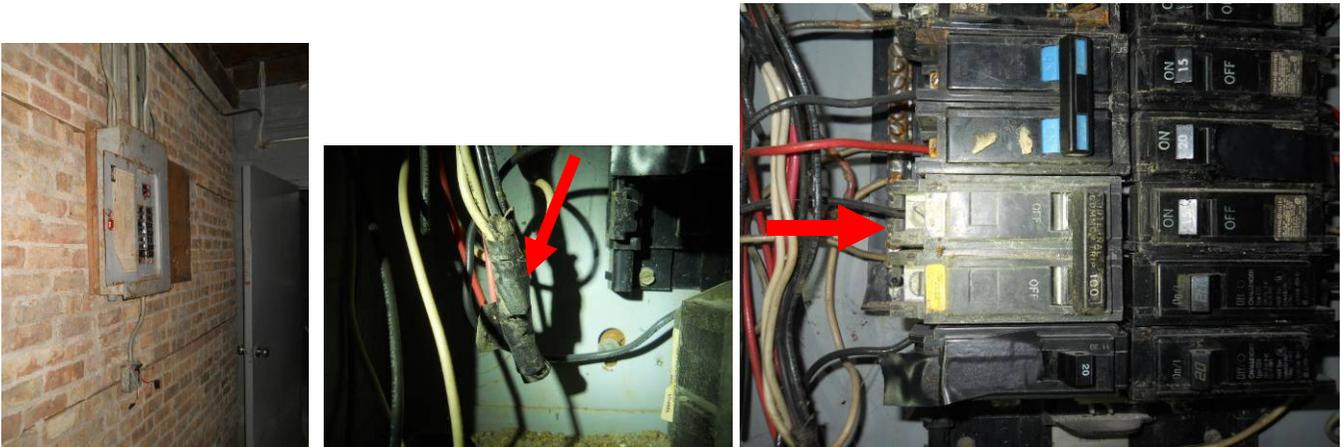
- There is a 100 amp subpanel on the east wall in the room with the sinks. Interior components are rusting. There are questionable conductor splices and grossly under wired circuit breakers (12 AWG with 100 amp). This panel might need replacement. Also, transformers should not be installed inside circuit breaker panels. Consult a licensed electrician.

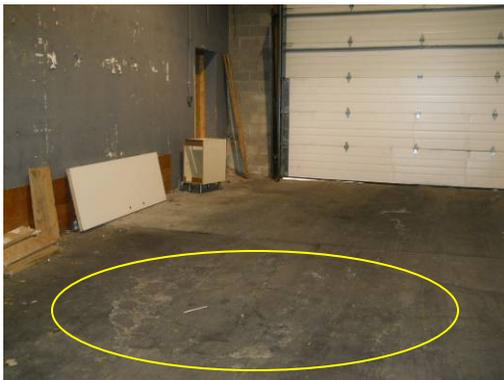
- A section of the concrete floor near the large overhead door is cracked and sunk but still serviceable.

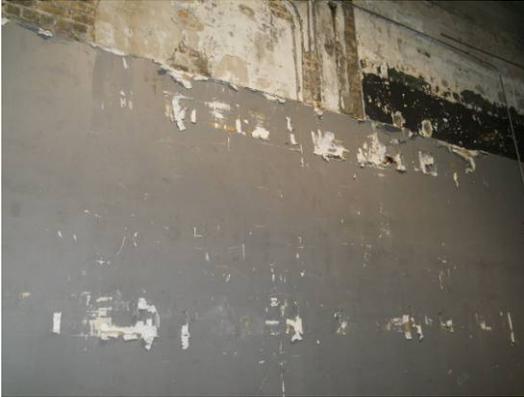
- Drywall has been installed against the west wall near the exterior overhead door and it is distressed and damaged.

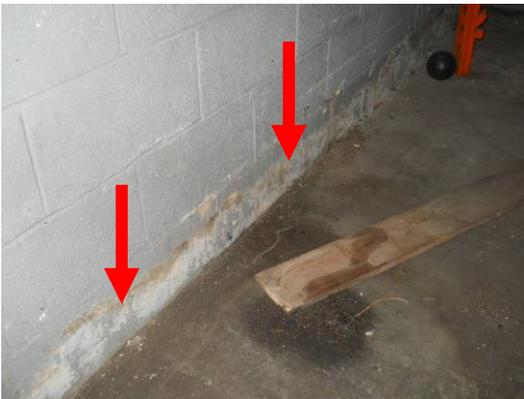
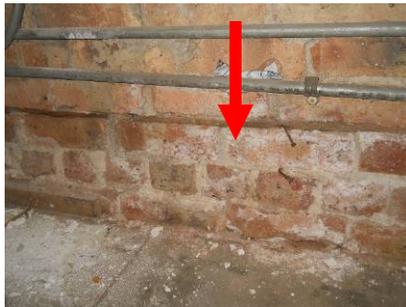
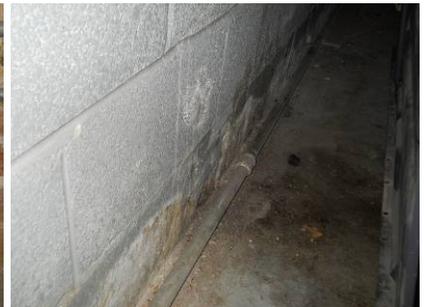
- The bottom panel of the large overhead door has a dent in it but this is not affecting its operation.
- The exterior overhead door should be equipped with safety reverse features but it is not.
- The interior brick and CMU walls next to the floor are damp with moisture staining. This is being caused by damp rise from the foundation and the fact that the building is not heeded very well. It would be best not to finish these walls with drywall but leave them exposed.

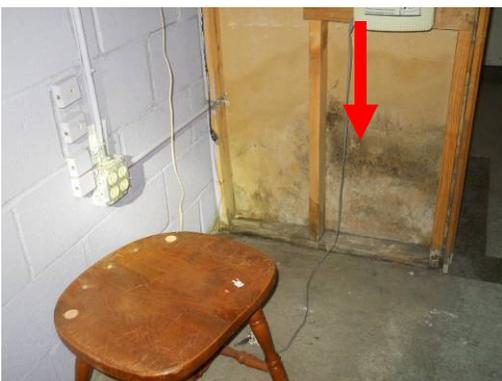
- The door and jamb at the exterior door just east of the overhead door is rusted.
- There is mold on the drywall inside that little vestibule room at the middle north side of the property. This is being caused by trapped moisture in a damp area. All moldy drywall should be thrown away. Consult the EPA regarding any mold concerns.

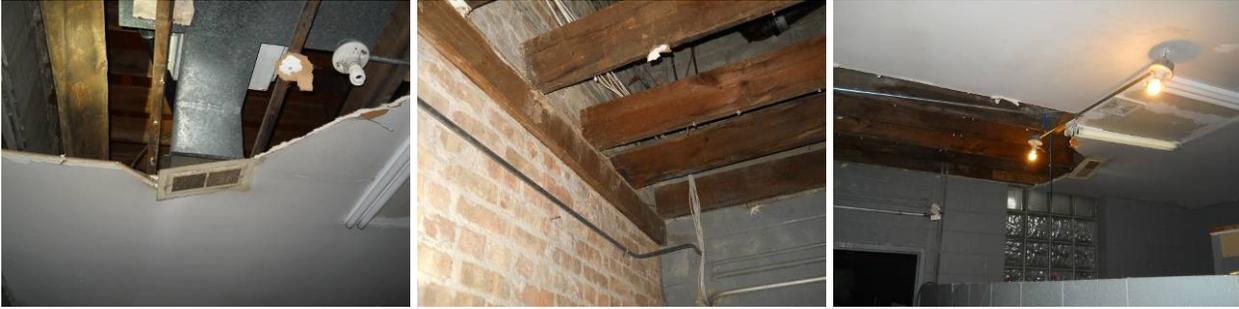
- The ceiling at the east room with the sinks and toilets is falling down. The ceiling joists are twisted, poorly installed, and are dangerous. Consult a qualified carpenter.

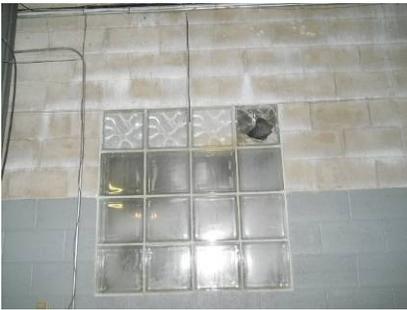
- One of the glass blocks at the north side of the warehouse wall is broken.
