# **INSPECTION CONNECTION, INC.**

## **INSPECTION REPORT**

**7923 S. SAMPLE, AVE., CHICAGO, IL**

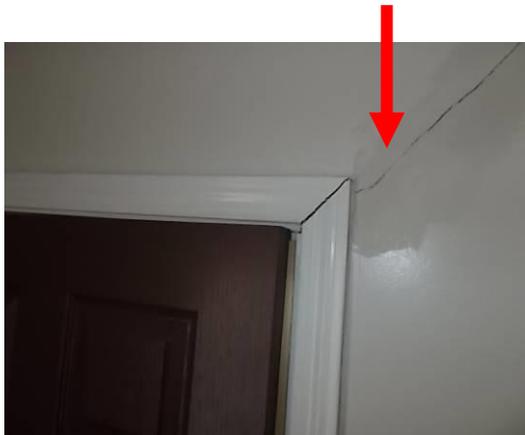
- The center wall and floor at the west units of the 5221 address has sunk at the north side of the units. The out of square doors and cracked drywall suggests this is an ongoing structural failure. The occupants I talked to said it is steadily getting worse. It looks to me as though the structural failure will be in the ceiling of the garden level of unit 1A. This ceiling area will need to be opened up to see what the problem is so it can be reinforced as necessary. Consult a structural pro or engineer to evaluate further.

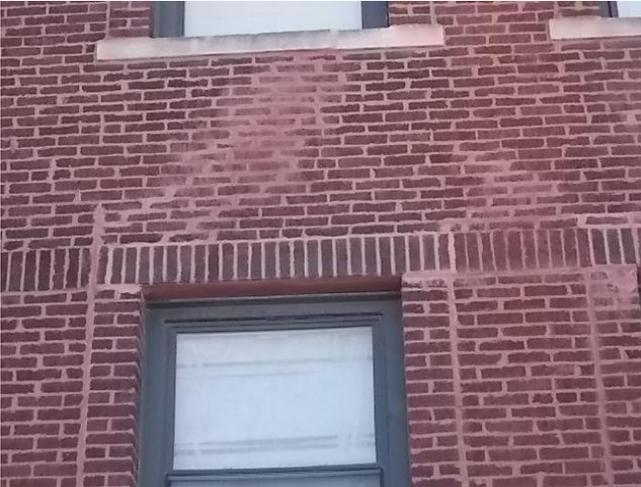
- Most of the lintels above the windows have been replaced. The adjacent mortar has been re-pointed but the work is very sloppy. Consult a masonry professional on the best method to clean this. Care must be taken not to discolor or damage the brick.

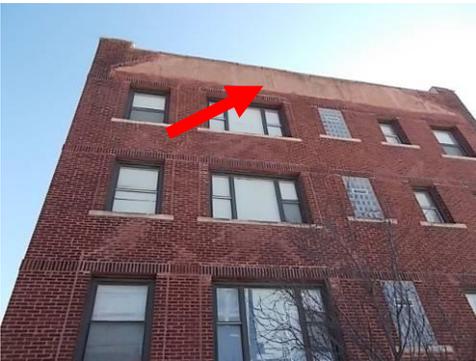
- The top of the building on the west side has been parged with mortar. This type of repair tends to crack off in time. So far, the work is in satisfactory condition. There may have been a small roof or façade here at one time.

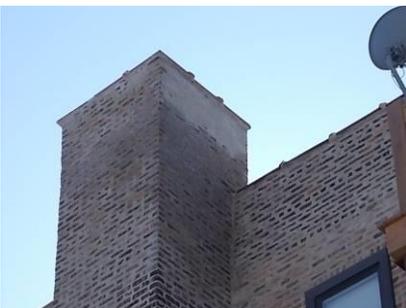
- The general condition of the exterior brick mortar joints is satisfactory.
- The masonry chimney at the north side of the building has been parged with mortar. This type of repair tends to fail in time. It's condition is currently satisfactory. The best I could tell this chimney is no longer serving any practical purpose.

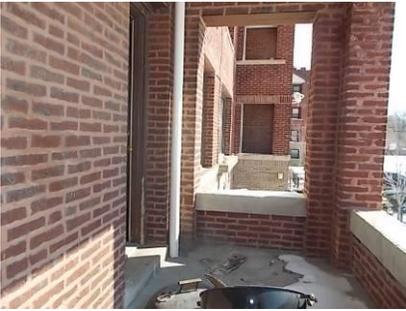
- The masonry guardrails at all of the front balconies are too low per current safety standards.

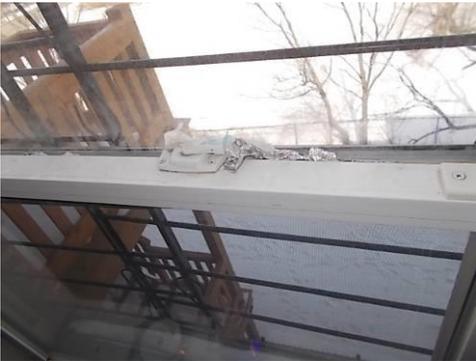
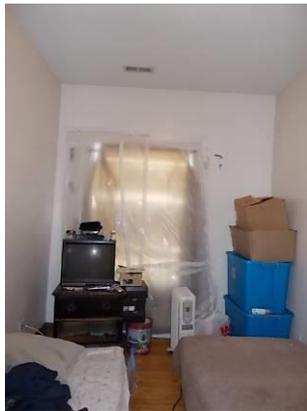
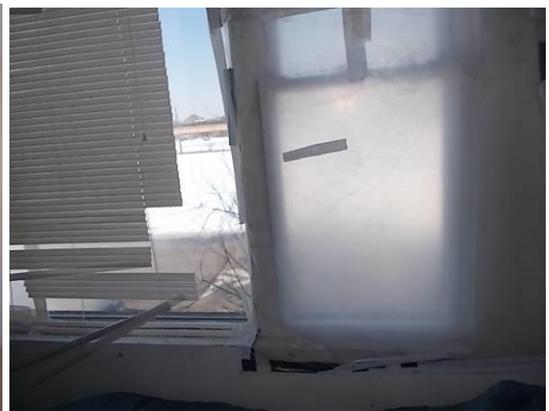
- The windows are in generally poor condition. Most of the units had plastic taped over them and most occupants I talked to said they are very drafty. Most of the dozen or so windows I tried to open and close would not lock properly to get a good weather seal. Many windows are missing screens. I recommend window replacement.

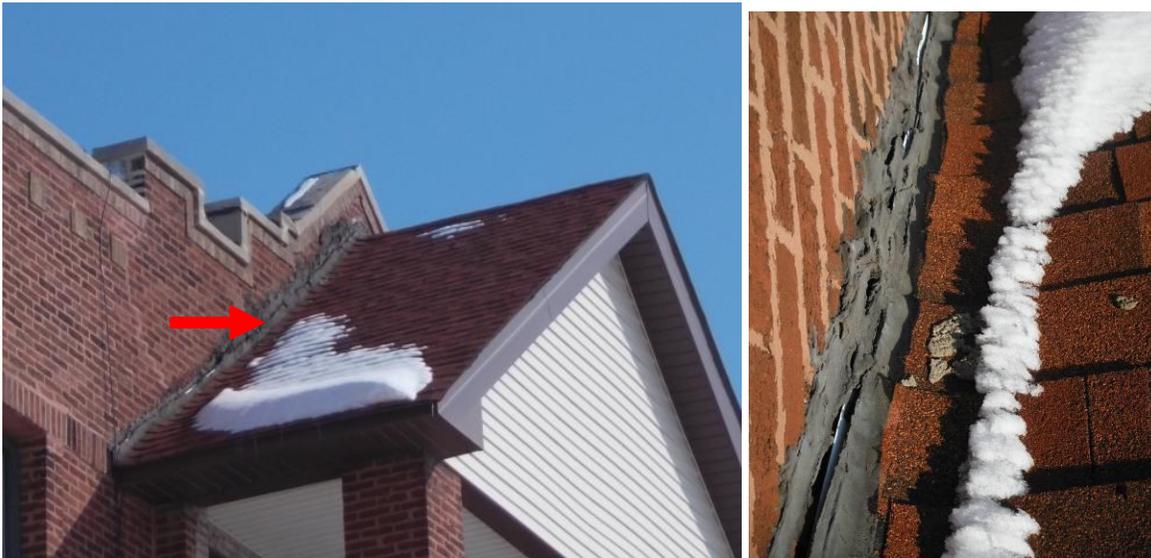
- All four of the pitched gabled shingled dimensional asphalt composition roof covers in front need to be properly flashed against the masonry walls. Roofing tar is not a flashing and will crack and leak which is what is happening here.

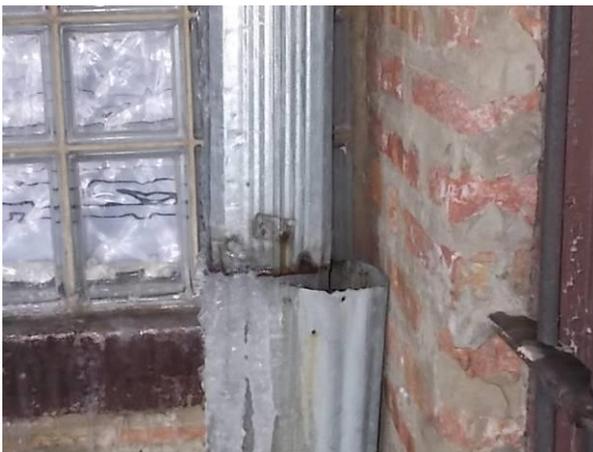
- The downspout at the far west side of the back decks is not sleeved properly into the downspout beneath it.

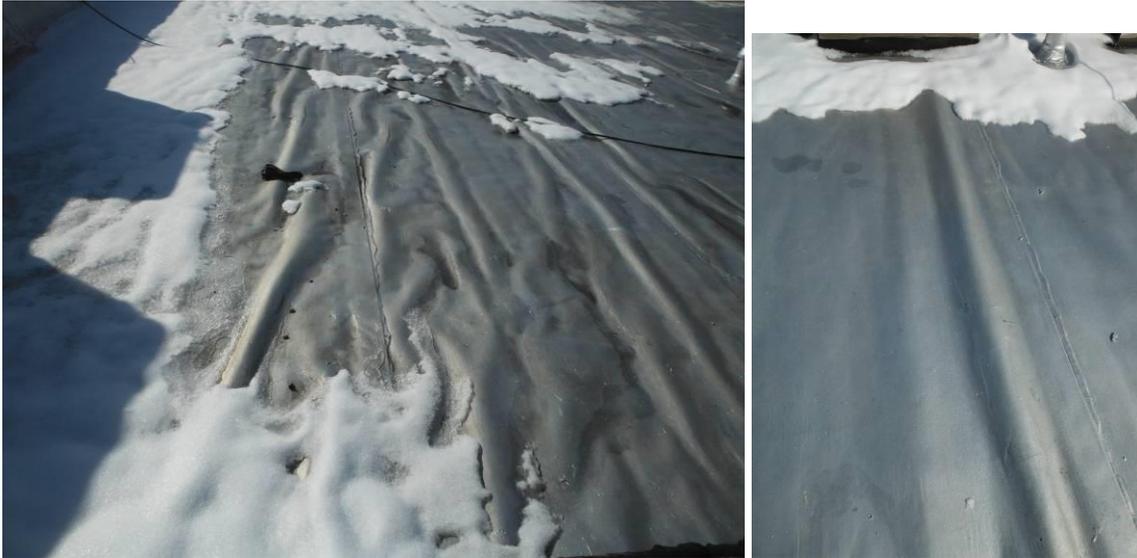
- The roof cover is mostly in satisfactory condition. There are a lot of large blisters that should be repaired by a licensed roofing professional at the west side of the roof. These areas will expand and contract, and be more prone to leaks.

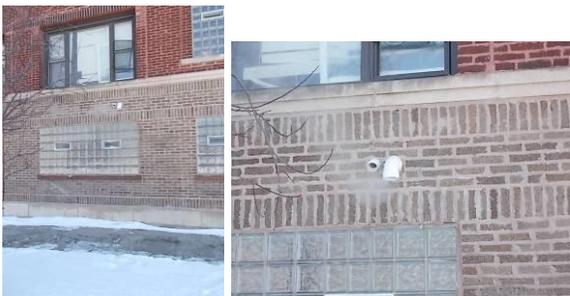
- High efficiency furnaces and water heaters are being vented out the walls at the west, north and east sides of the building. These should not be vented over public walkways due to the acidic nature of the condensate.

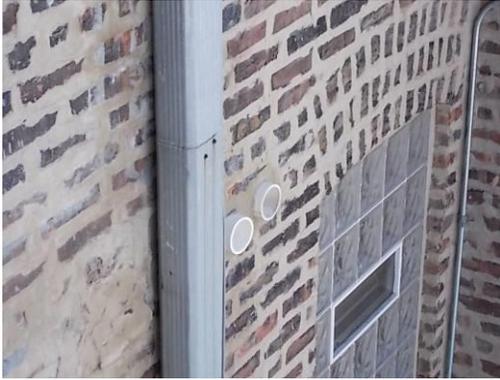
- The furnace/water heater vents at the north side of the building do not extend far enough from the wall. Have a licensed HVAC professional correct this.

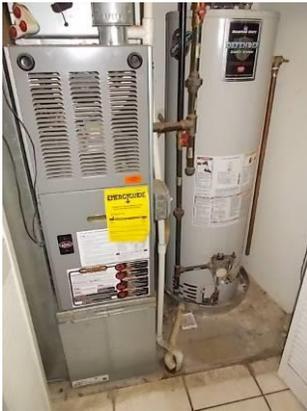
- All of the interior units have air-conditioning air handlers above the furnaces. Since the AC condensate can leak in damage the property, all of these units should have been installed in a pan with the drain leading to a proper place of disposal and/or have some kind of moisture sensitive shutoff system.

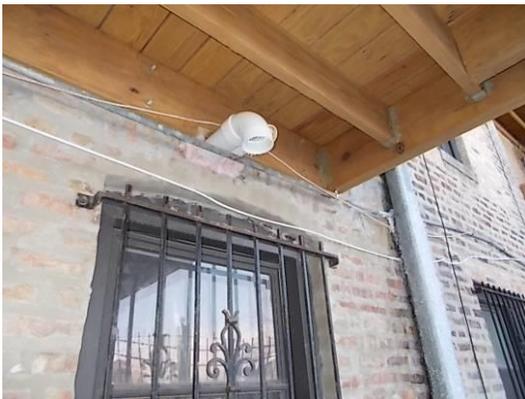
- Most of the furnaces have dirty or collapsed filters. Dirty or improperly installed filters will shorten the service life of the furnaces and cause air-conditioning failure.
- Some of the units have humidifiers. The water to all of these was turned off. I recommend you have all of the humidifiers removed. They are difficult to keep clean and they tend to leak.
- All of the furnaces need to be cleaned and serviced. The induction and blower fans are all very dirty.
- Furnace vents should not be installed beneath decks or above public walkways.

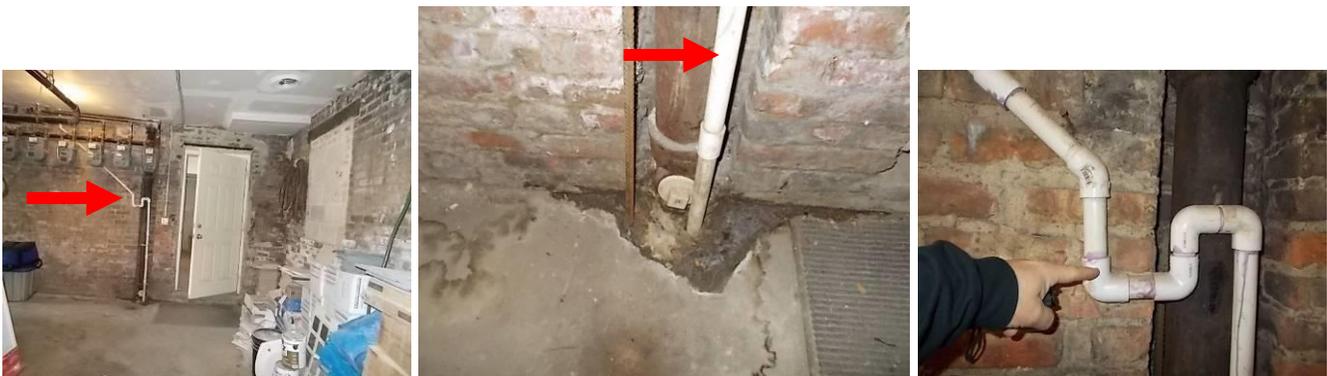
- The condensate drains for the air conditioners should not be run directly into sewers or sewage ejector pits which is apparently being done. When the HVAC system runs it is under negative pressure and sewer gas can get sucked back into the HVAC system ducts. All of the AC condensate drains next to the furnaces should have traps. Consult a licensed HVAC professional.

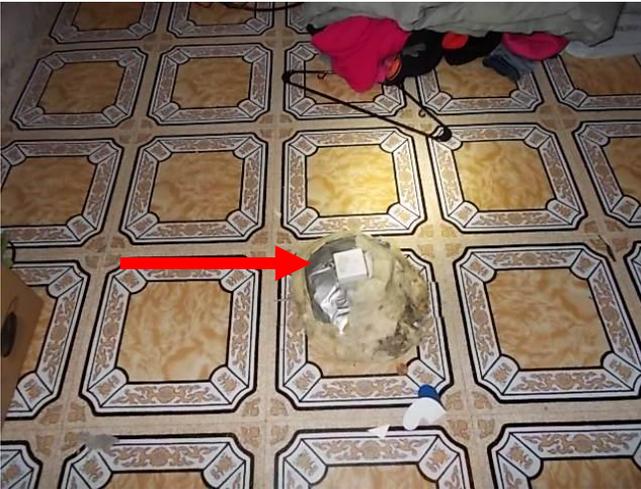
- Each unit has its own water heater dated 2005 or 2006.
- It looks like there is a water main shutoff for each unit in the furnace closets.
- FYI: I ran all the fixtures and flushed toilets, etc., however, it is not uncommon for buildings, especially older ones to have hidden sewer problems. Drain pipes under the ground can leak attracting tree roots and other blockage problems. The underground sewers for this building are probably about 100 years old. Problems can be latent (waiting to happen) so I recommend a TV scope of the underground drain/sewer by a licensed plumber to see if there are any issues.
- There is a sewer drain clean-out in the floor at the utility room behind 5219, unit G. The drain plug is taped up with masking and duct tape. The room smells like sewage so something wrong is going on here. Have a plumber check this out.

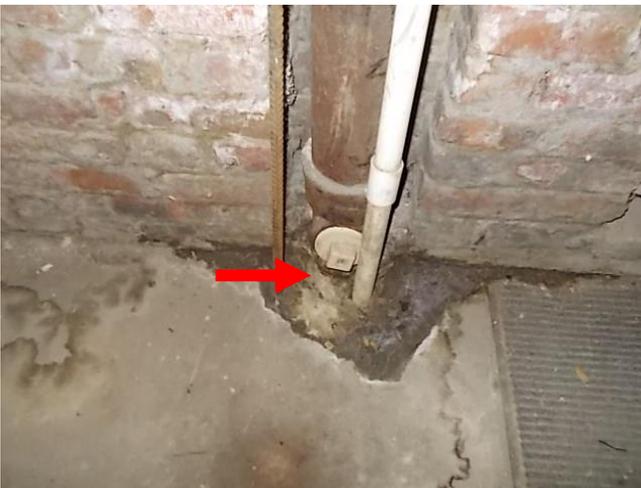
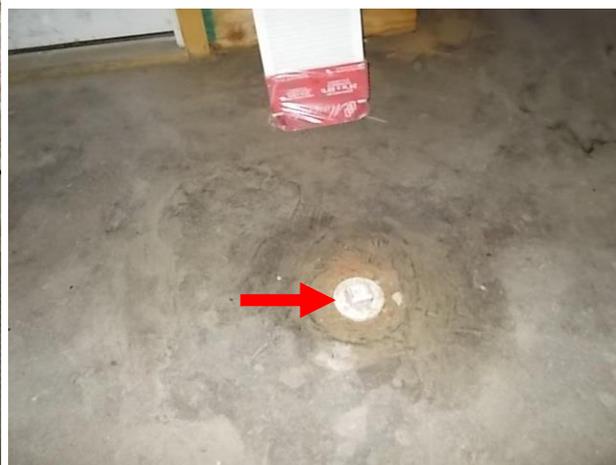
- One of the main sewer stacks at the lower level common area in the middle of the building is leaking at the floor level. The floor drain in the common area office has also been plugged suggesting sewer backup problems. A licensed plumber needs to evaluate. I recommend a TV sewer scope of the underground sewers.

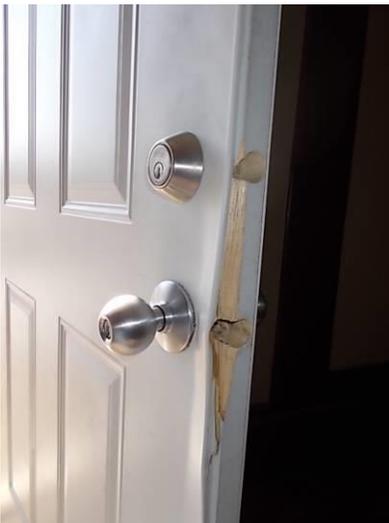
- Warn the occupants that flammables and other clutter should not be stored against the water heater or furnace.
- The front exterior door to 5219 is badly damaged and needs replacement.

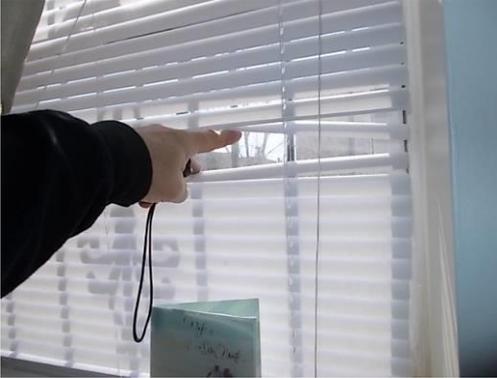
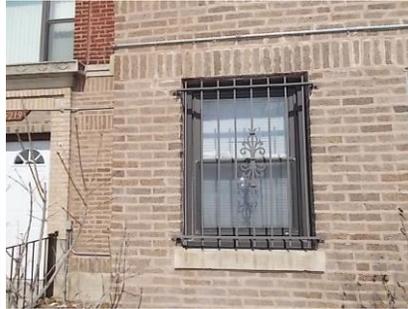
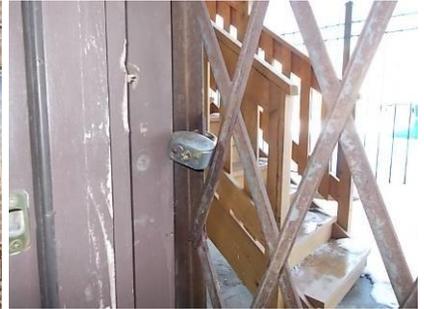
- Many of the units had bars on the bedroom windows and locked bars at the back porch doors. This is a dangerous emergency egress hazard. All bars on windows should be on the interior with quick release/unlock opening systems. Every habitable room especially bedrooms need at least one window to get outside in the event of an emergency. Glass block windows are in egress hazard. Exit doors should not be padlocked.

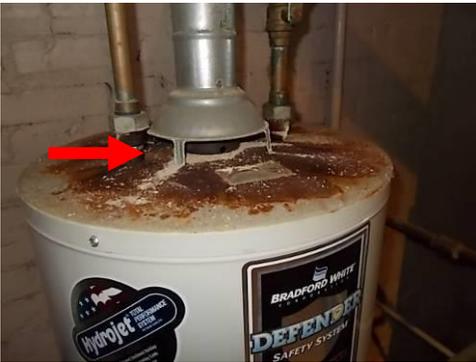
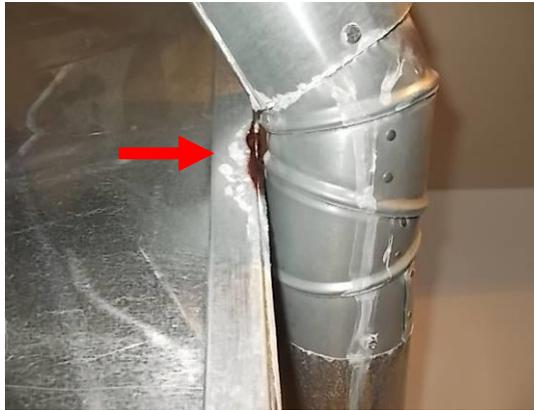
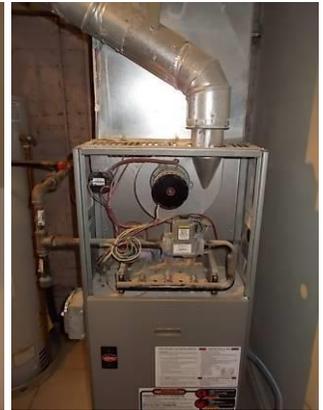
- The concrete floors at all of the balconies have cracks in the masonry. The concrete is not loose however, so this should be a minor maintenance issue.
- Both the furnace and water heater in the lower level common area office are showing signs of poor drafting and vent gas spillage. This can be a dangerous carbon monoxide hazard. These appliances should not be used until an licensed HVAC professional evaluates to see why these are not drafting properly.

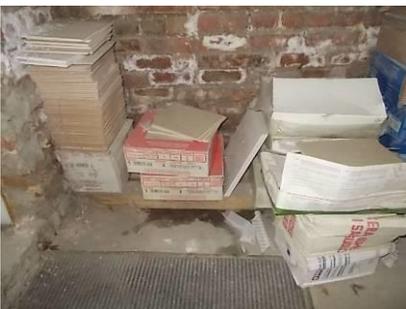
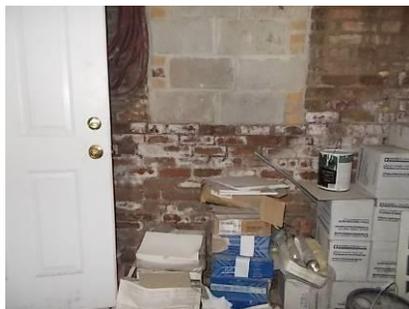
- The lower brick walls at the middle common area of the building show signs of mild seepage and efflorescence on the brick.

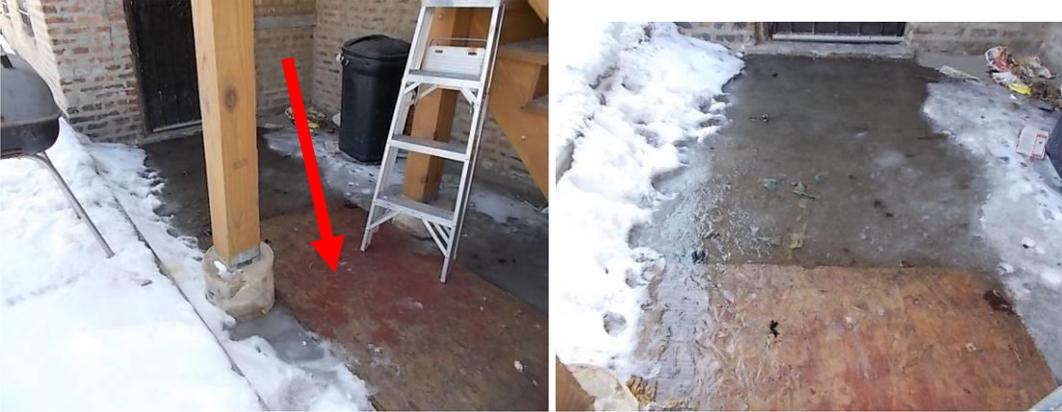
- There are some open areas of the ceiling at the center lower level common area utility room which compromises the required smoke and fire separations between the two levels.
- Plywood has been thrown over the floor at the exterior east side of the building. I was told there is a hole beneath this that has to be fixed. This is probably a plumbing issue but I do not know for sure. Ask the sellers for more information about this.

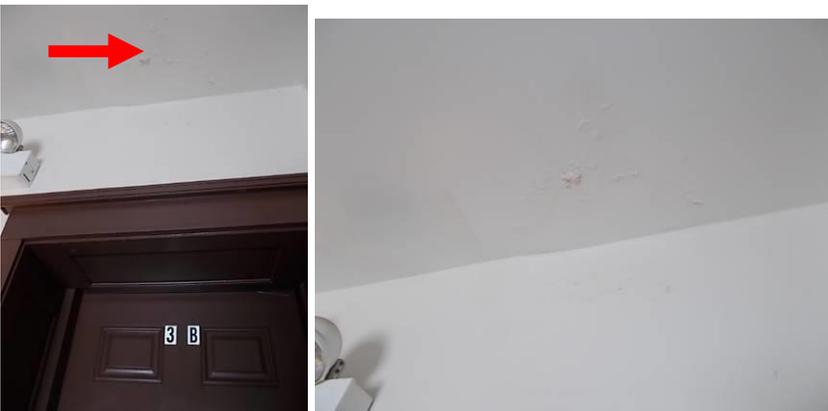
- There are water stains and peeling paint at the ceiling at the top level of the front stairway of 5223. This tested dry with my moisture meter during the inspection.

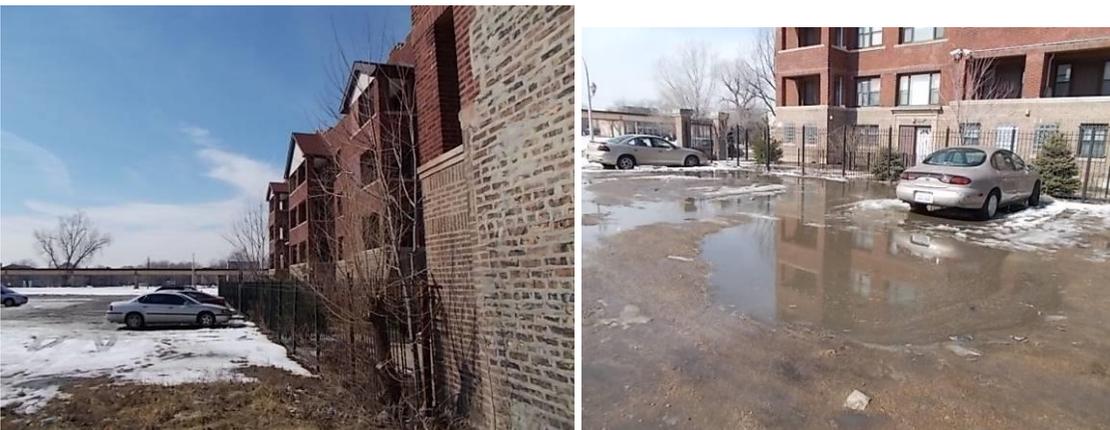
- The vacant lot to the south of this building is on higher ground so rainwater will run towards the property. The front sidewalk area of the property was beginning to flood during my inspection. I did not see that this was causing any noticeable adverse effect.

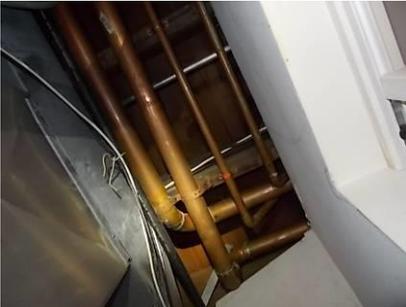
- The ceiling above the furnace is lacking a fire and smoke separation from the unit above it.

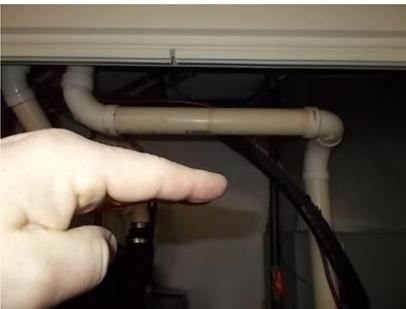
- The PVC furnace vent should have a continuous upward pitch otherwise it might have drafting and condensing problems.

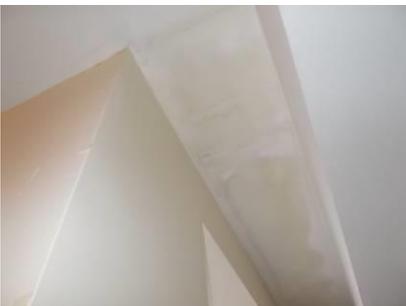
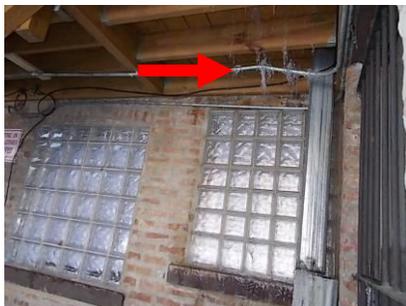
- Water is entering through the wall and ceiling at the back porch area of this unit (5219-#G). This is due to the excessive water running down the exterior walls which is being caused by a frozen gutter and downspout. The water is most likely entering through the porch ledger bolts that been drilled into the side of the building. A flashing is needed above this ledger or perhaps some type of awning at the porch above may help alleviate this.

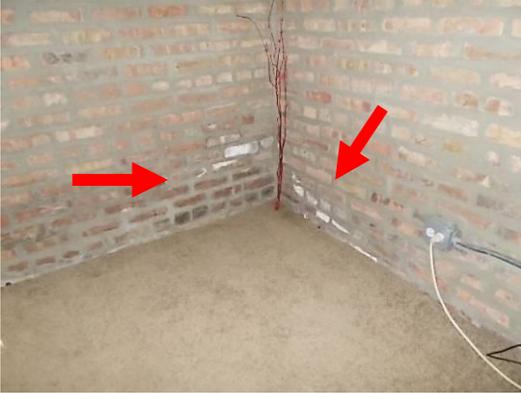
5219, #G

- The east bedroom in this unit has signs of dampness and efflorescence at the brick in the corner of the room. This is being caused by damp rise through the masonry brick from groundwater. It is to be expected at the lower grade levels. It is best to not drywall over these walls as mold can develop behind the drywall. The west rooms of this unit are drywall. I did not see any signs of mold or smell any dampness.

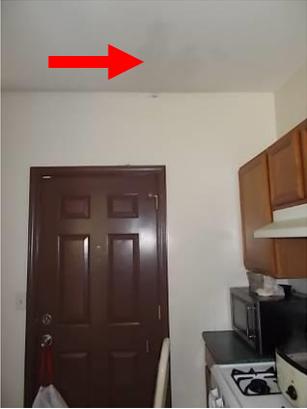
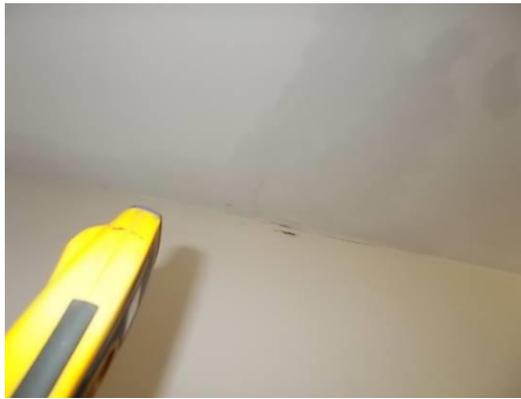
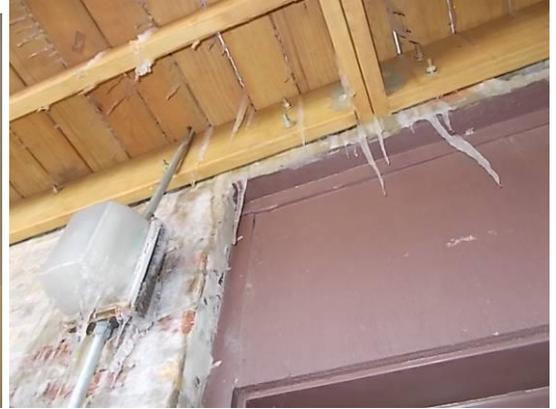
5219, 2B

- The kitchen ceiling is wet at the north wall in 5219, unit 2B. This is an area of the building where the gutters are filled with ice and water is running down the outside walls. I suspect water is entering through the deck ledger bolts. Exterior flashing is needed.

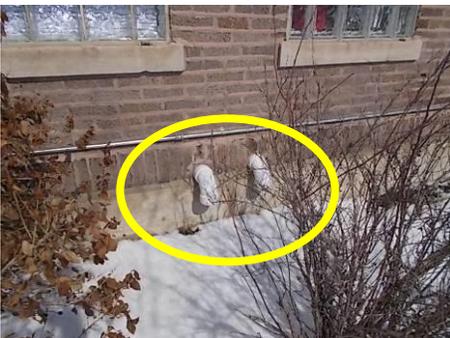
- The furnace in 5221, unit 1A does not work. Have a licensed HVAC professional evaluate and fix as necessary. The occupants say the furnace has not worked properly for over two months. One obvious problem is the outside vents need to be at least 12 inches above the snow line. The vents have probably been buried in snow for most of the winter.

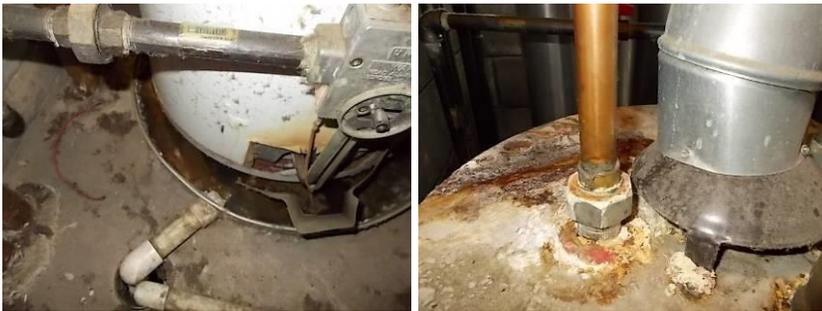
- This unit is vacant.
- The water heater in unit #2B, 5221, is leaking. The fittings and the top jacket are rusted out. It needs replacement.

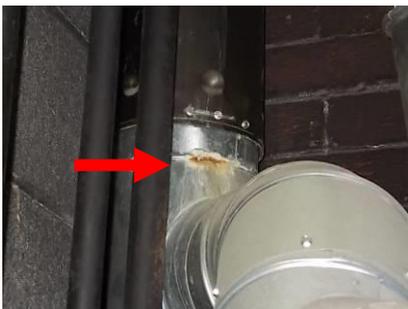
- There are moisture stains at the furnace vent at 5221, unit 2B which means it is not drafting properly. This can be a dangerous carbon monoxide hazard. The room for this furnace and water heater does not have adequate air for combustion of the gas appliances so this may be part of the problem. Have a licensed HVAC professional check this out.

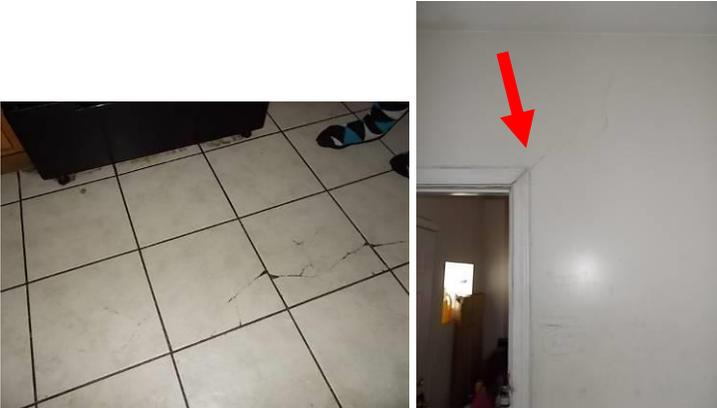
- The kitchen floor has many cracked floor tiles and the doorframe to the bedroom next to the kitchen has sunk and drywall has cracked. See the structural section and summary of this report regarding structural failure this part of the building.

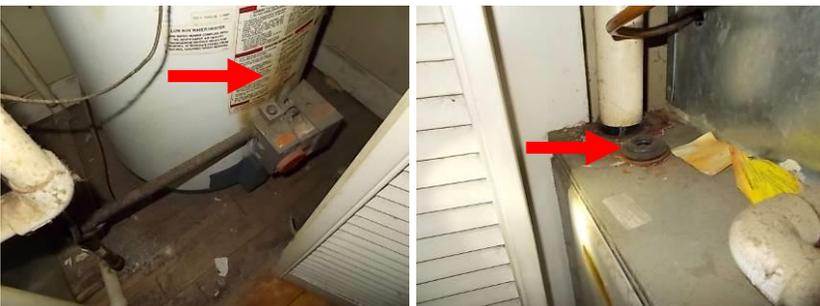
- No pan was installed beneath the water heater to protect the property in case it leaks.
- There are moisture stains at the furnace vent and scorch marks at the water heater burner chamber which suggests poor drafting of these appliances. I was unable to open the top panel on the furnace because the closet door was in the way. Have a licensed HVAC professional evaluate further.

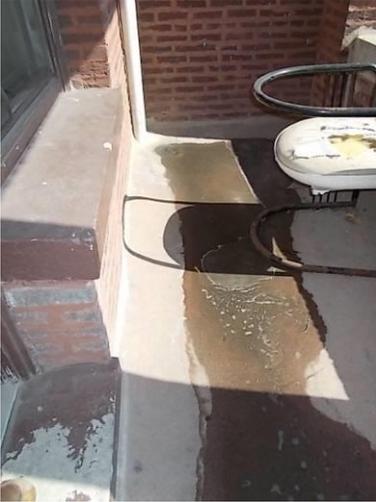
5223, 1A

- The bathroom sink drains very slowly.
- The balcony floor drain is plugged. Water is puddling.

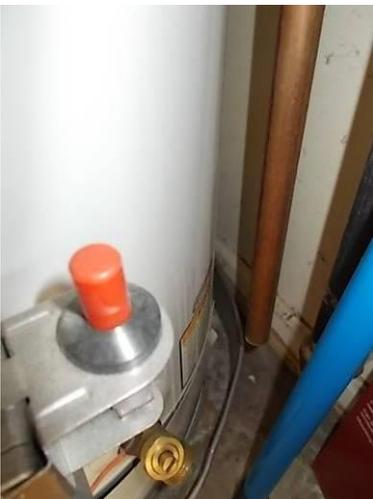
- The extension pipe from the temperature pressure relief valve on the water heater needs to extend into the pan beneath the tank.

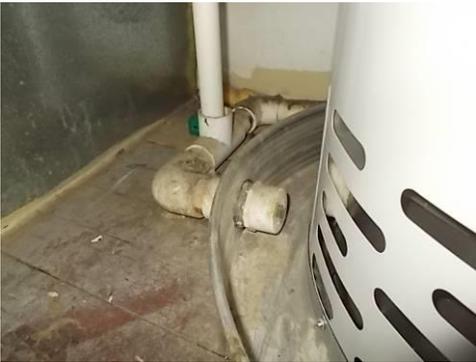
- The occupant complained about the kitchen electrical outlets shutting down sometimes when he is running appliances. Have an electrician check this out.
- The extension pipe from the temperature pressure relief valve on the water heater needs to extend into the pan beneath the tank.
- The PVC drain leading from the pan beneath the water heater is plugged inside the pan for some reason. Have a plumber correct this.

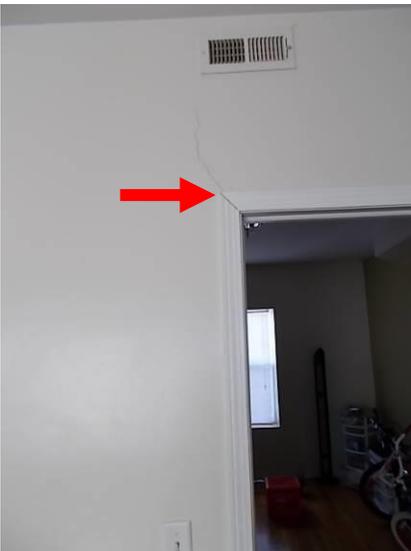
- One of the kitchen cabinet drawers is broken.
- There is an open knockout in the circuit breaker panel that should be plugged.
- The drywall has cracked at the bedroom door corner suggesting there has been some recent movement/settlement of the floor in this unit.

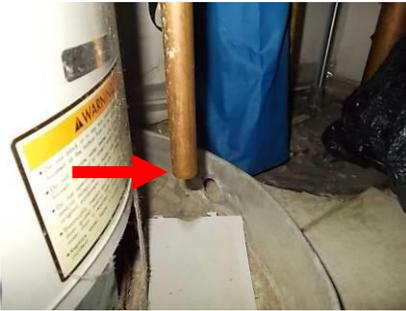
- The pan beneath the water heater has no drain pipe attached to it.

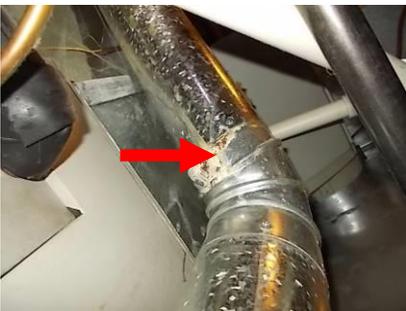
- The ceiling above the furnace and water heater in the utility closet is not drywalled for a proper smoke and fire separation between this unit and the unit above it.
- The louvered door in front of the furnace closet is badly damaged.
- There are moisture deposits at the furnace vent suggesting this appliance is not venting properly. Have a licensed HVAC professional check this out.

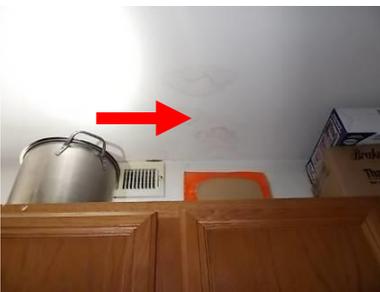
- There is water damage to the ceiling above the bathroom sink. This was dry during the inspection in I assume it is from an old plumbing leak from the unit above it.
- There is a lot of mold at the ceiling above the tub due to poor ventilation and excessive moisture.
- The ceramic shelf beneath the glass block window in the tub area has cracked grout that should be repaired ASAP.
- The bathroom sink drains slowly.
- The ceiling above the kitchen cabinets at the north wall has water stains. This was dry during the inspection.

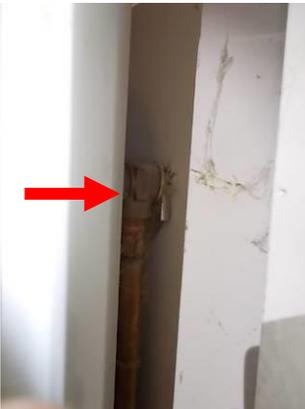
- The temperature pressure relief valve for the water heater has been jammed against the wall in the utility closet. This will prevent testing or resetting the valve.
