INSPECTION CONNECTION, INC.

ADDRESS: 1015 W. ELM PLACE

SAMPLE INSPECTION REPORT

1015 W. ELM, CHICAGO, IL

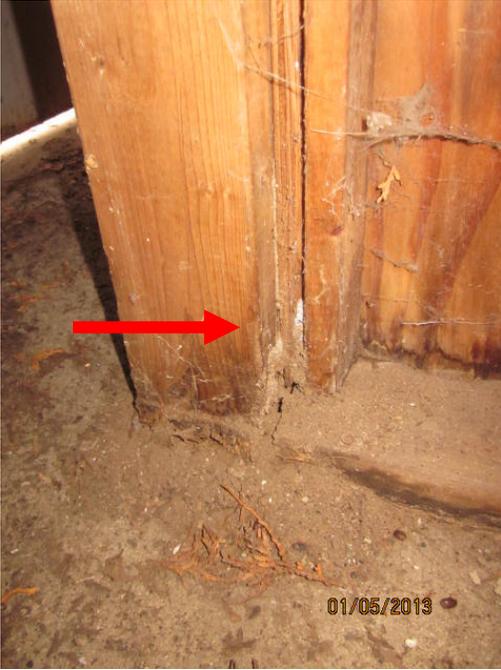
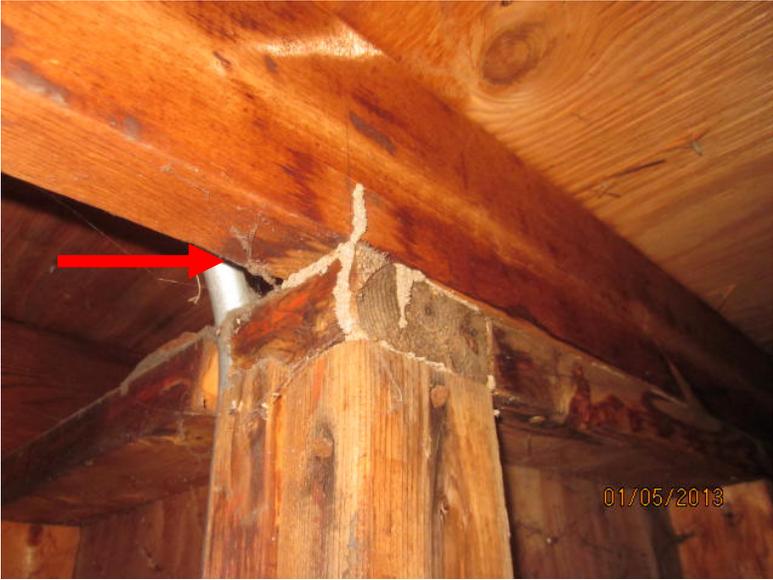
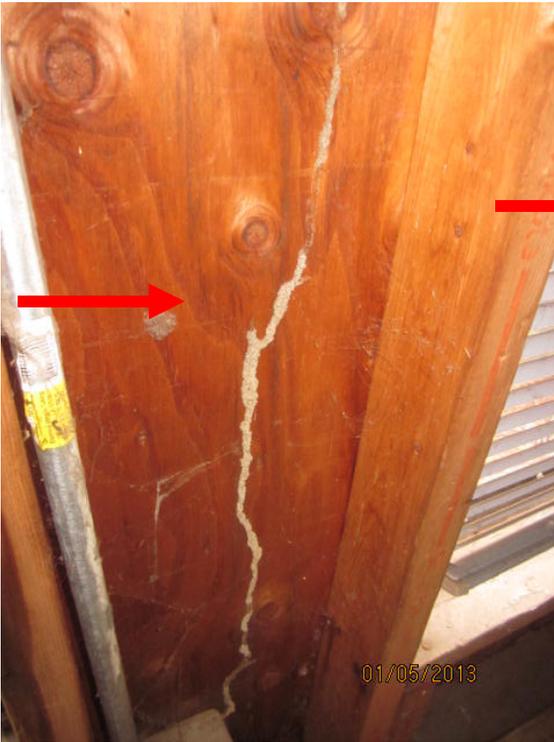
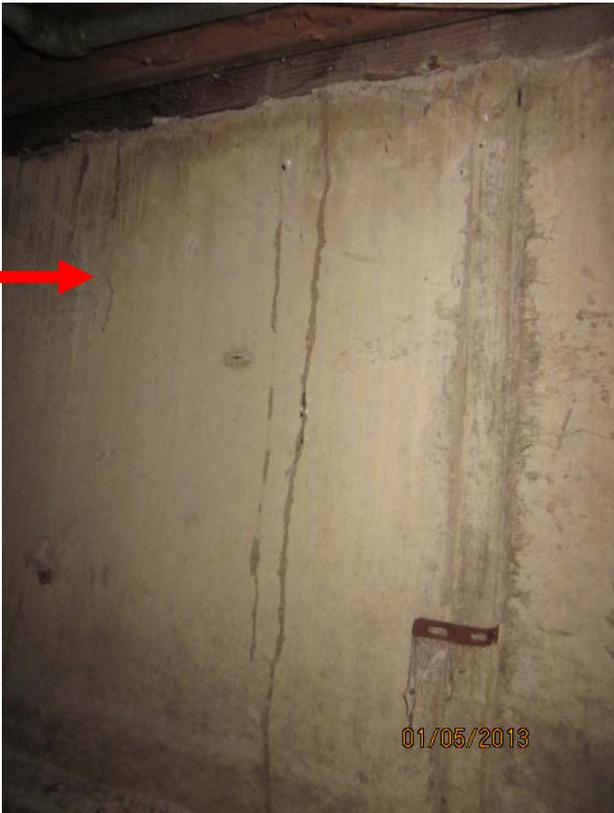
- There are signs of termites in the crawlspace at the northwest corner and in the back and closed porch shed. Consult a termite pro.

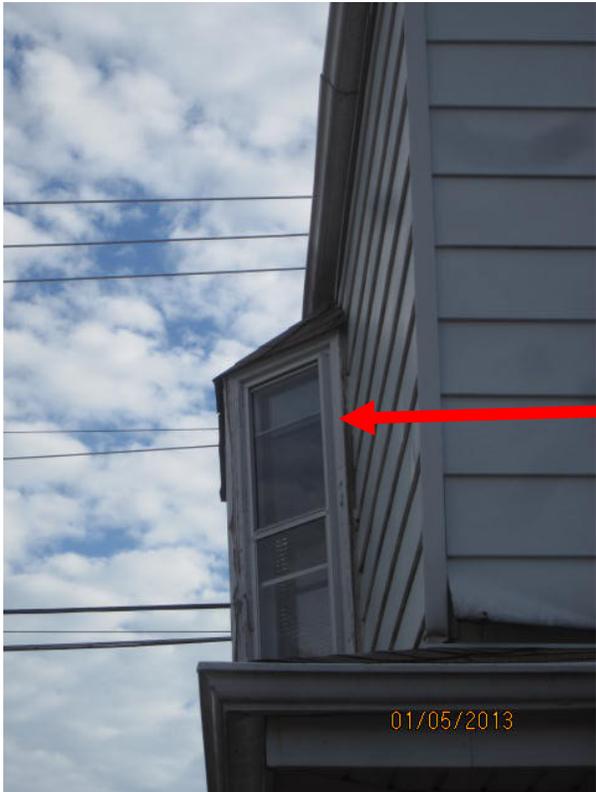
- The front second-story bay window is leaning outward and the eave beneath it has sagged. This suggests structural failure. Have a structural pro or qualified carpenter evaluate further.

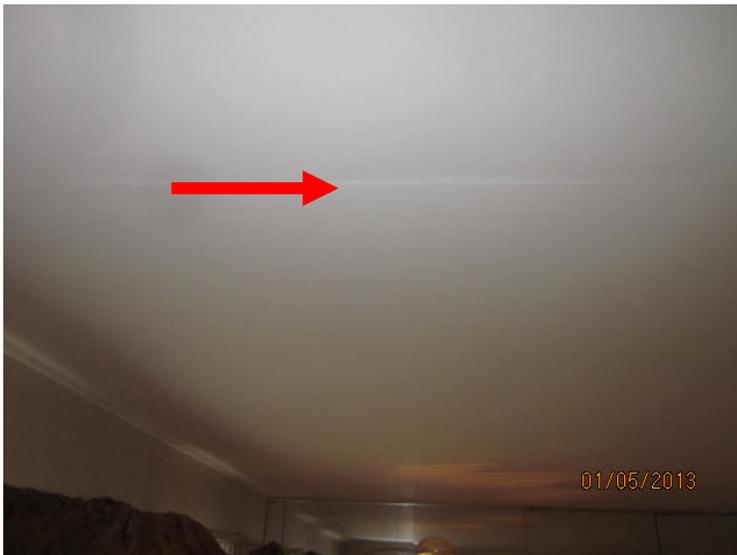
Front room ceiling

- The top level bedroom floor is very springy. I suspect that the joists beneath are under framed. There is patched drywall in numerous places of this room and there are cracks developing in the ceiling in the room beneath this. A qualified carpenter or structural professional needs to investigate this further which may require opening up the ceiling in the front room beneath.

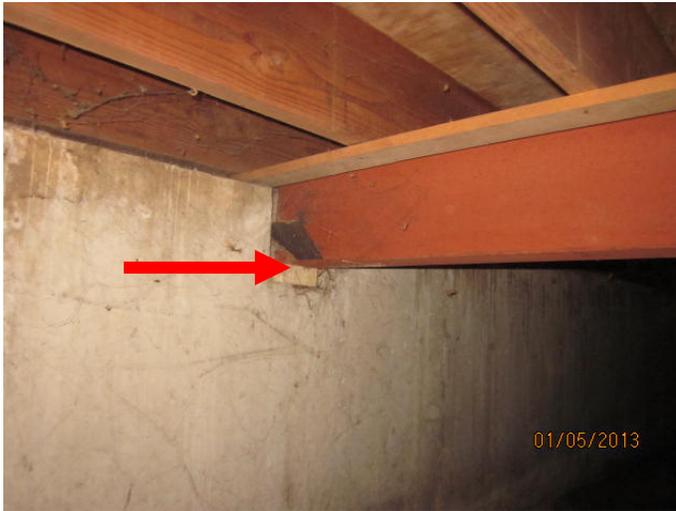
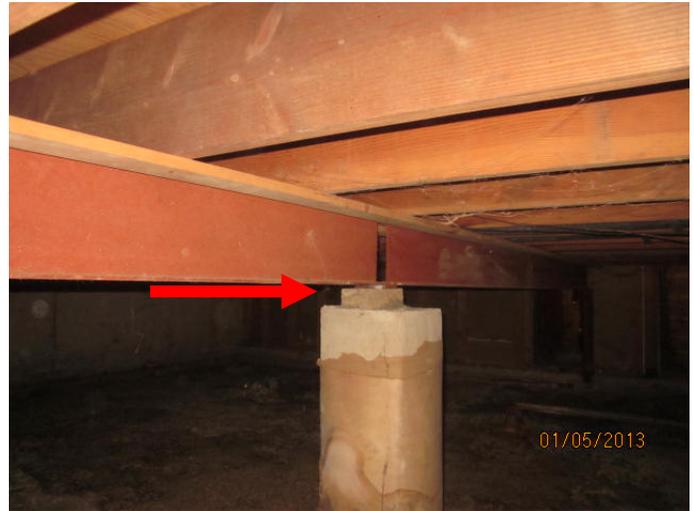
- The center steel beam in the crawlspace on the north side should be grouted into the wall to keep it secure and this being should be secured to the masonry column in the middle of the crawlspace. The post supporting the beam on the south side is rusting at the bottom but so far this looks superficial and I don't think you have to do anything about this.

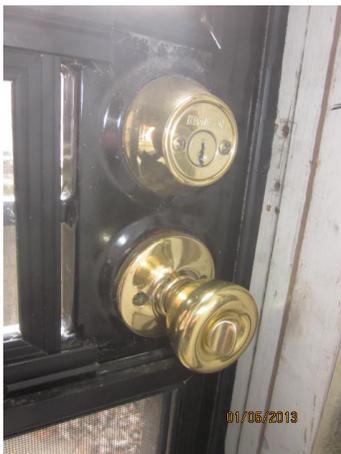
- A key should never be needed to exit the doors of your house. This is an emergency egress hazard.

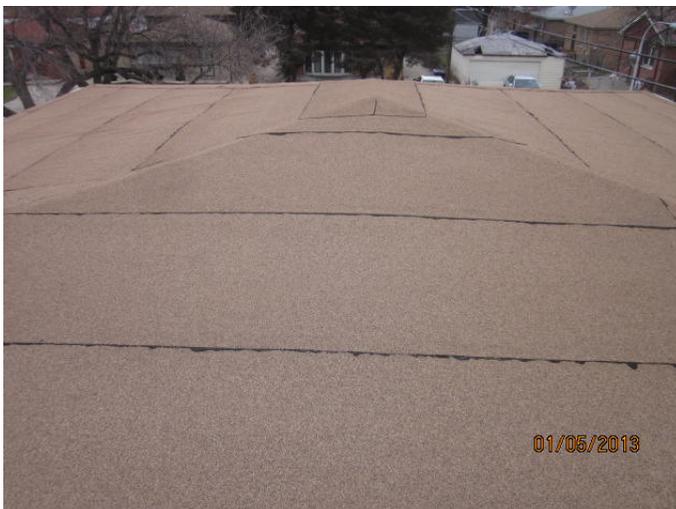
- The chimney needs brick and mortar repair near the crown.
- The front roof cover installation is satisfactory, however, there are no roof vents. This will not allow the attic to breathe and may void the roof warranty. When walking on this roof, the sheathing felt springy and spongy beneath my feet which suggests interior moisture problems. When I was in the house under this area of the roof I could locate no hatch to access the attic. I recommend that an attic access hatch be installed so the condition of the attic can be inspected.

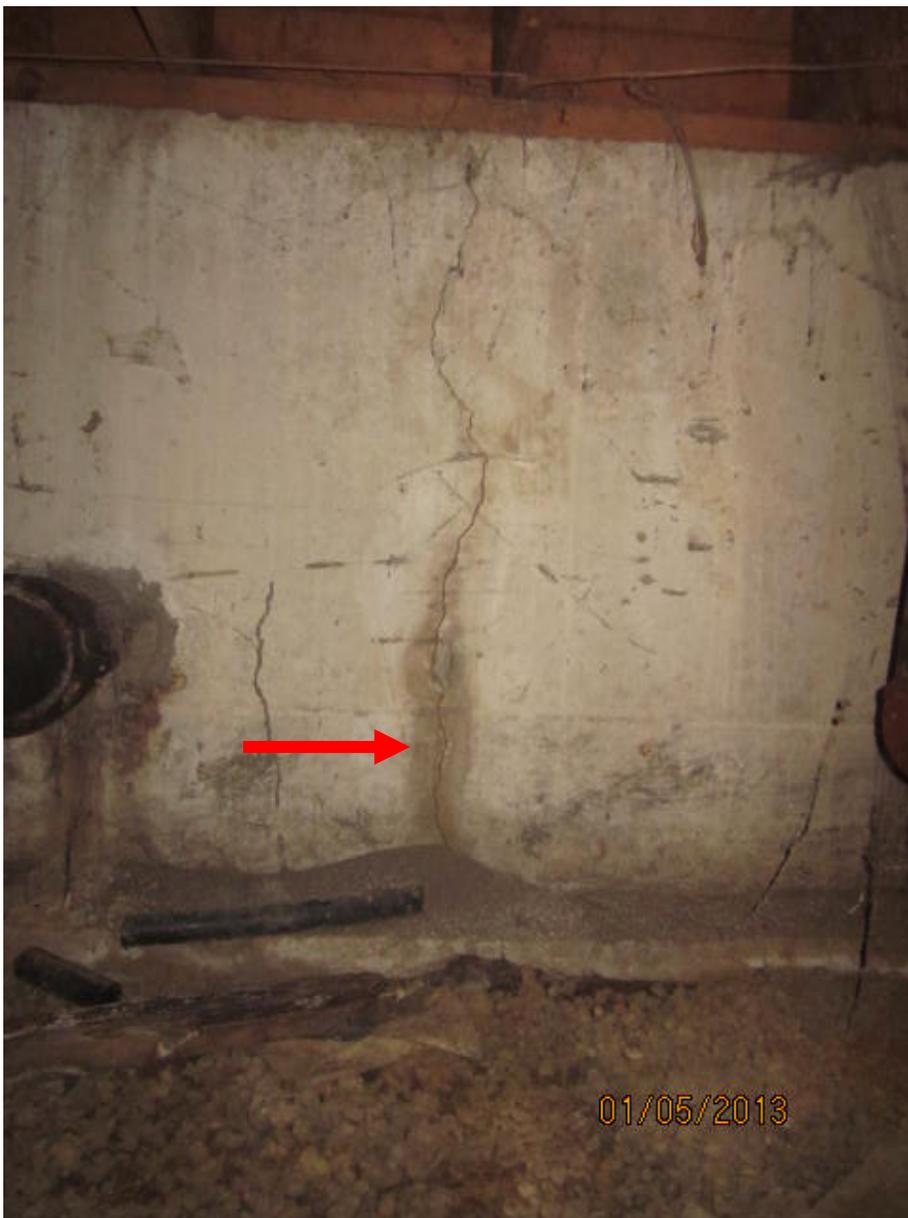
- The crawlspace floor is damp and should be covered with a heavy 6 mm minimum plastic moisture barrier to hold the dampness down.
- I inspected the crawlspace by crawling through it.
- There is a crack in the crawlspace foundation on the west side that looks like it has active seepage. Consult a waterproofer.

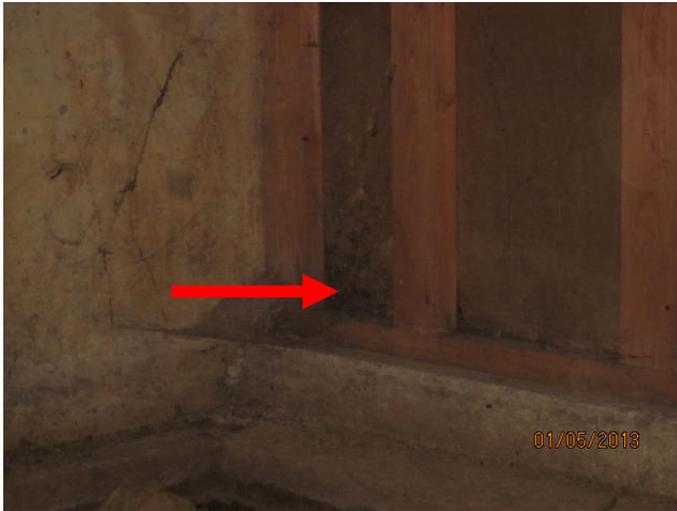
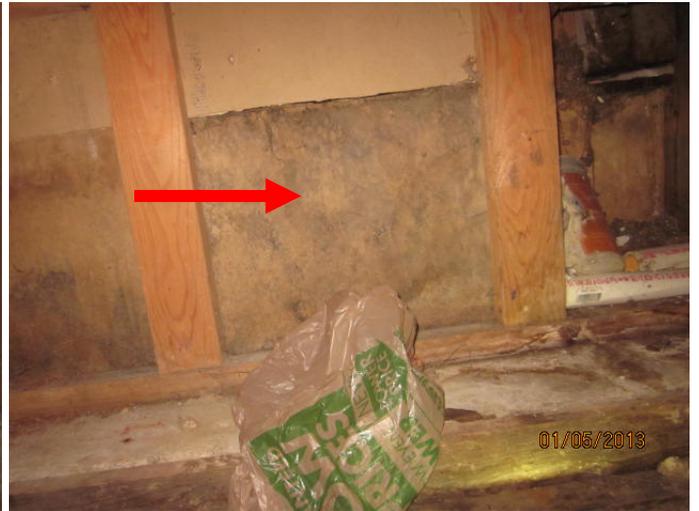
- There appears to be some spotting of mold on the drywall along the south side of the crawlspace. Building codes call for ventilation in crawlspaces and this crawlspace has none. Regardless of code, I am not sure that adding vents is a good idea. Replace the moldy drywall and monitor any moisture problems to see if venting the crawlspace is necessary.

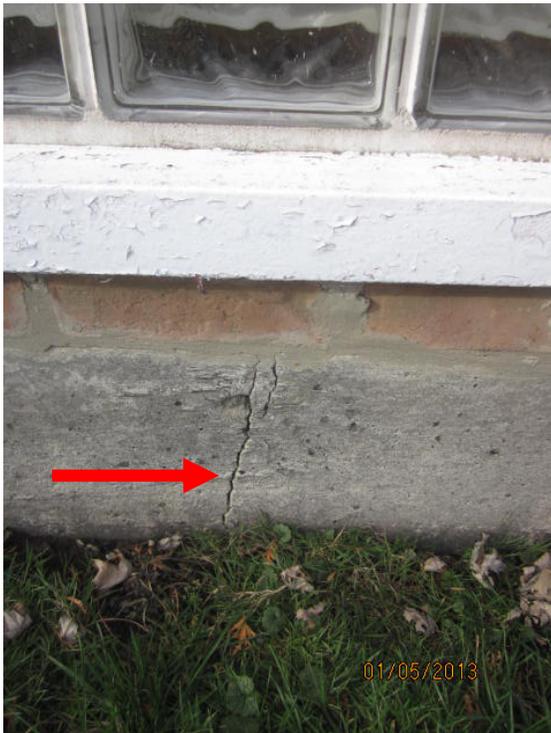
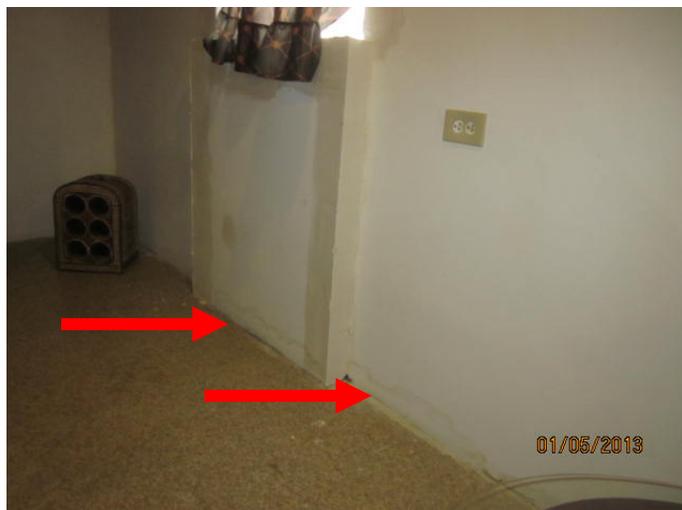
- There is a crack in the foundation under the window on the east side with signs of seepage. Consult a waterproofing pro.

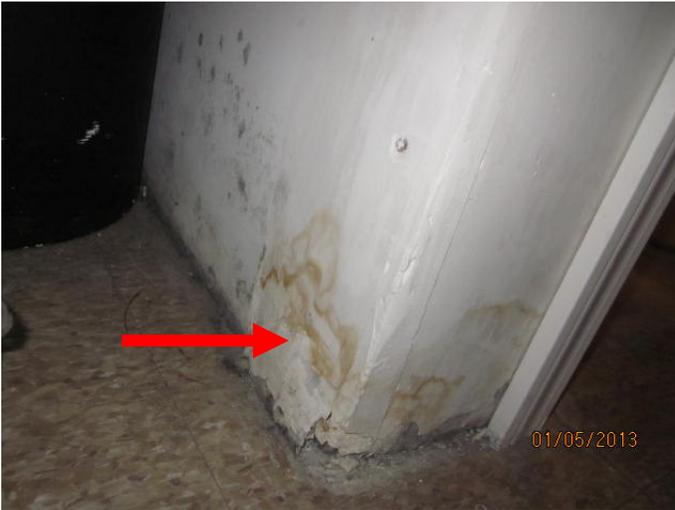
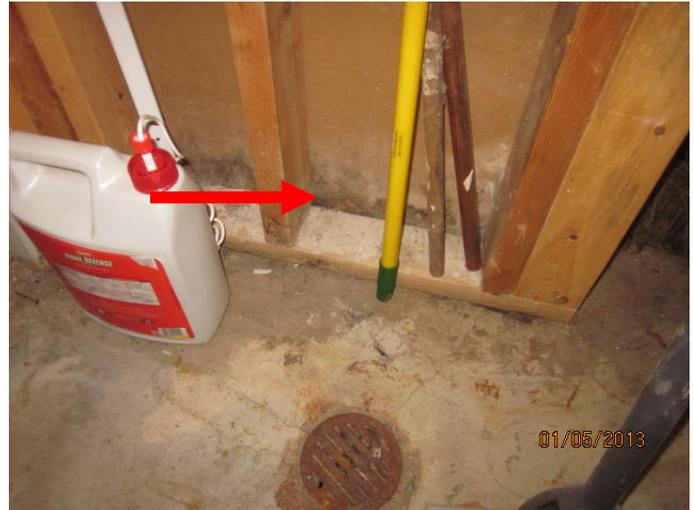
- There are water stains at the wall next to the floor drain near the furnace in the basement suggesting that the drain backed up. See my remarks about having the sewer system TV scope by a plumber.

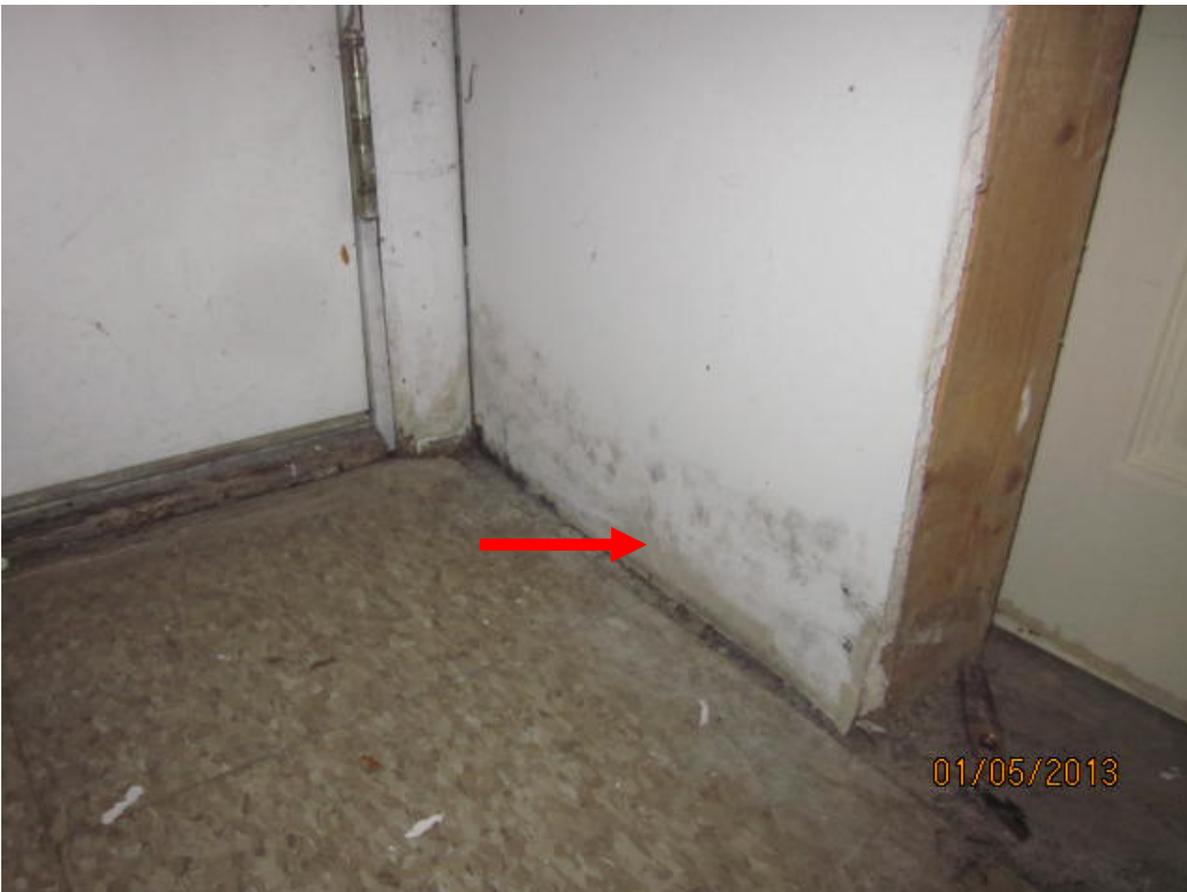
- There are water stains on the wall next to the door going to the outside. This was probably caused by the floor drain outside the basement door being clogged.

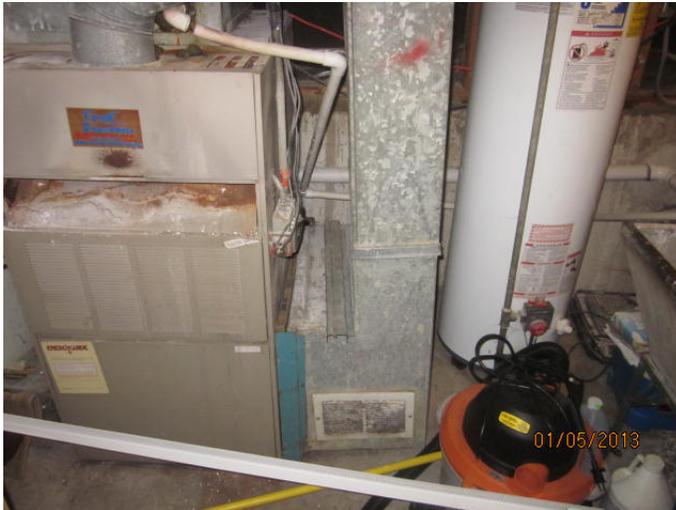
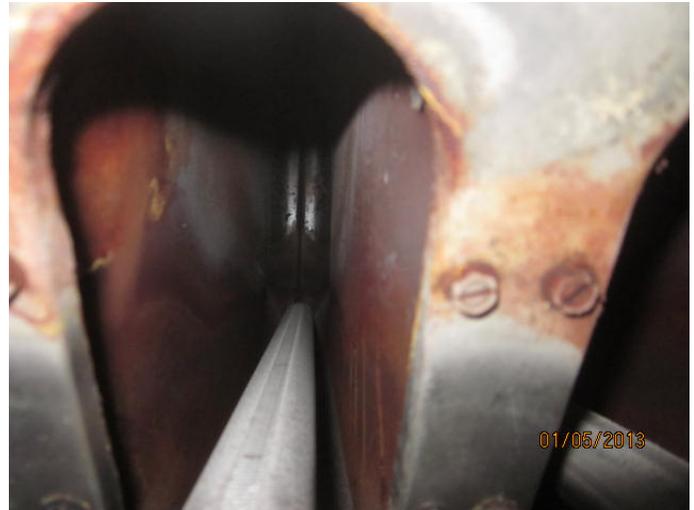
- The furnace is old and well past expected life. There is excessive rust at the lower heat exchanger. I recommend replacement. Consult a licensed HVAC Pro.

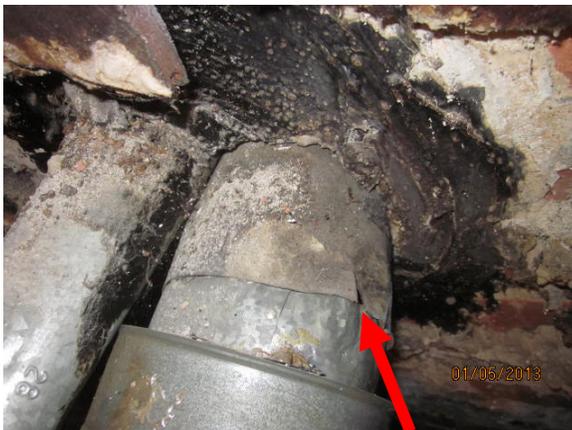
- I did not see any heat ducts for the basement or for the basement bathroom.
- There is an open return duct right next to the furnace. This needs to be closed off to prevent any type of back drafting from the gas appliances which can be dangerous.
- There is no heat duct to the master bathroom at the top level.
- Both the vents for the water heater and the furnace are improperly pitched towards the chimney. The vent for the furnace has been downsized and there is a gap at the connection right next to the chimney. This is a carbon monoxide hazard. Also, it looks like roofing cement has been smeared around the chimney where the vents enter it. Roofing cement is a combustible material and could give off noxious fumes. Have a HVAC pro.

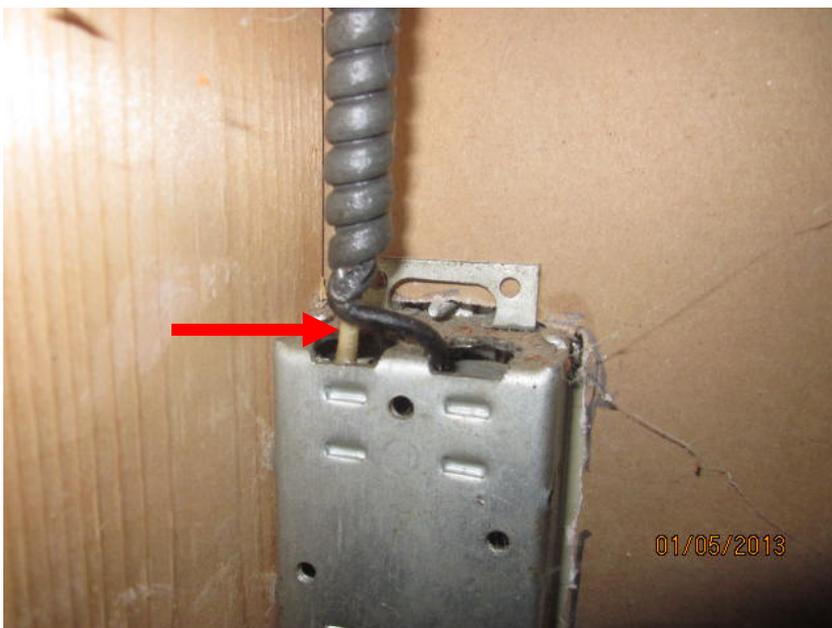
- The main electrical panel is missing its cover. A cover should be installed.
- Install a grounded electrical outlet near the washer and dryer in the basement so an extension cord does not have to be used.
- The light switch for the light next to the front door is defective and needs replacement.
- There is one under wired and one double tapped circuit breaker in the main panel.
- A light switch near the laundry area in the basement has been wired with BX without connectors. Have an electrician correct.

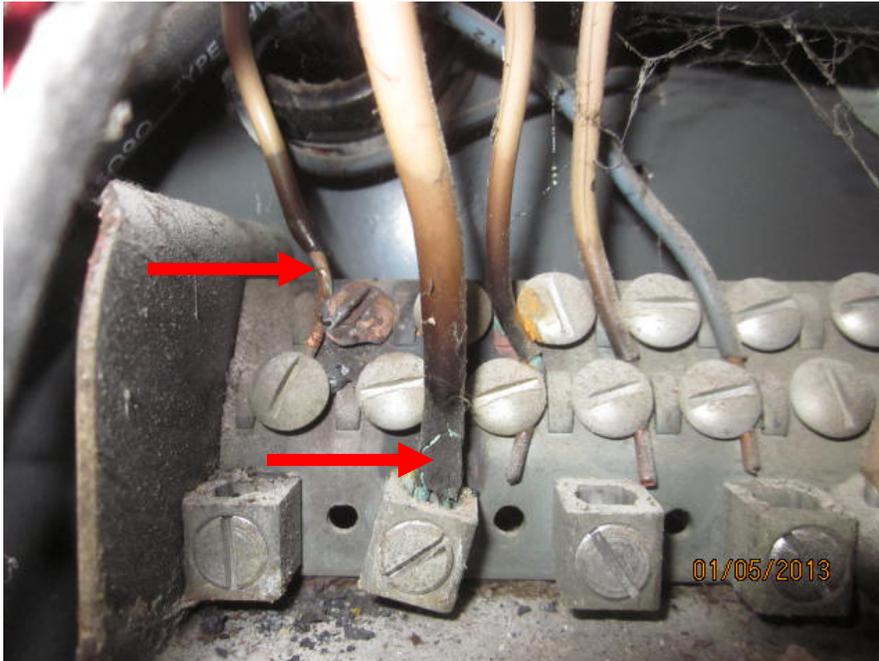
- There are three scorched neutral wires in the main electrical panel at the bus connections. Have a licensed electrician evaluate as soon as possible.

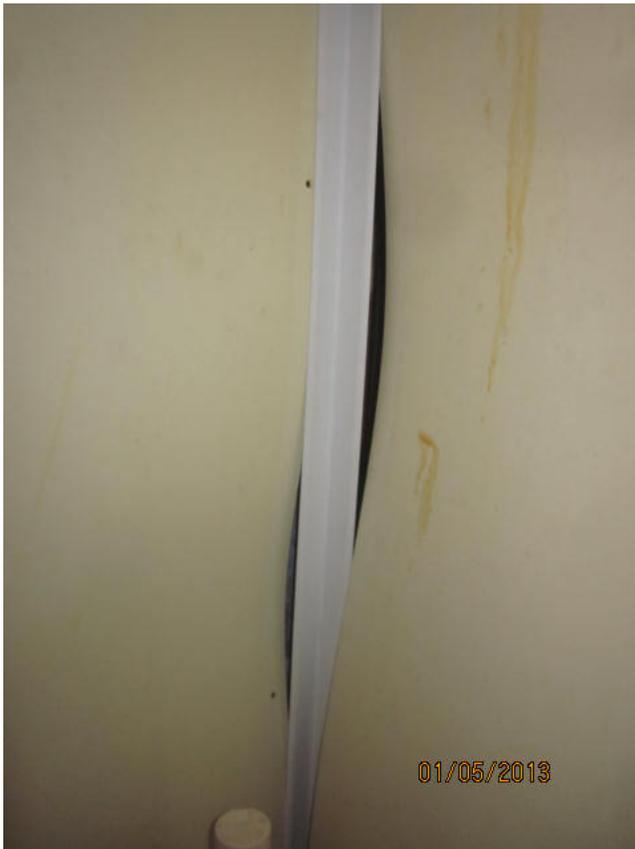
- There is poor hot water volume to the sink faucet.
- The basement shower stall walls are falling apart so the shower is not usable.

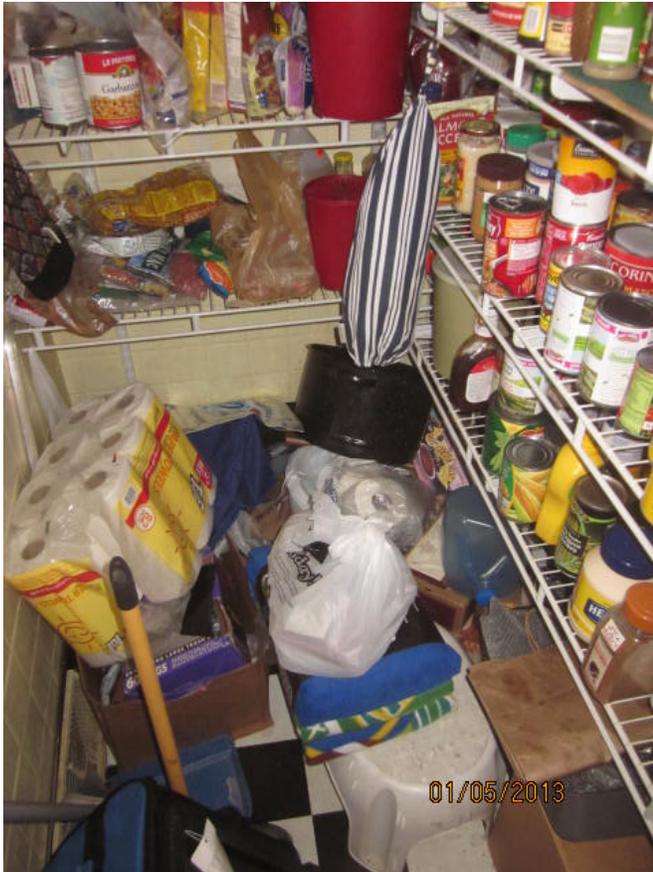
- Cabinets and counters are satisfactory.
- Appliances are satisfactory.
- The refrigerator was not inspected. I was told the seller was taking it with them when they leave.
- The drain beneath the kitchen sink needs to be reconfigured by a plumber. It is improperly installed and pitched.
- The sink fixture spout is loose.
- I was told that this kitchen pantry used to be a bathroom. It was filled with storage, etc. and I did not check to see if this was true or not.

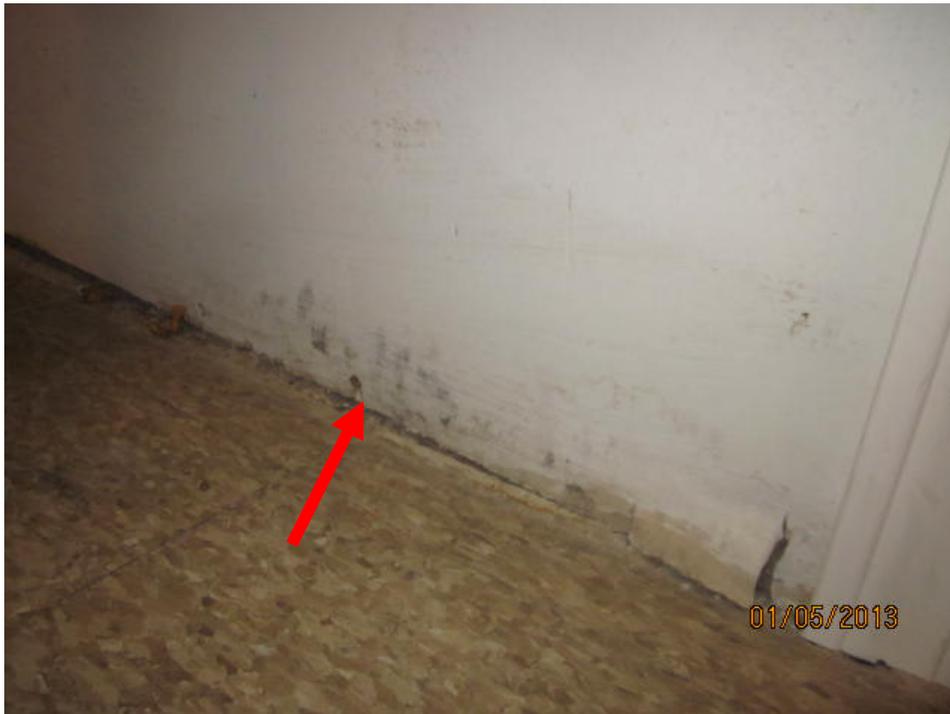
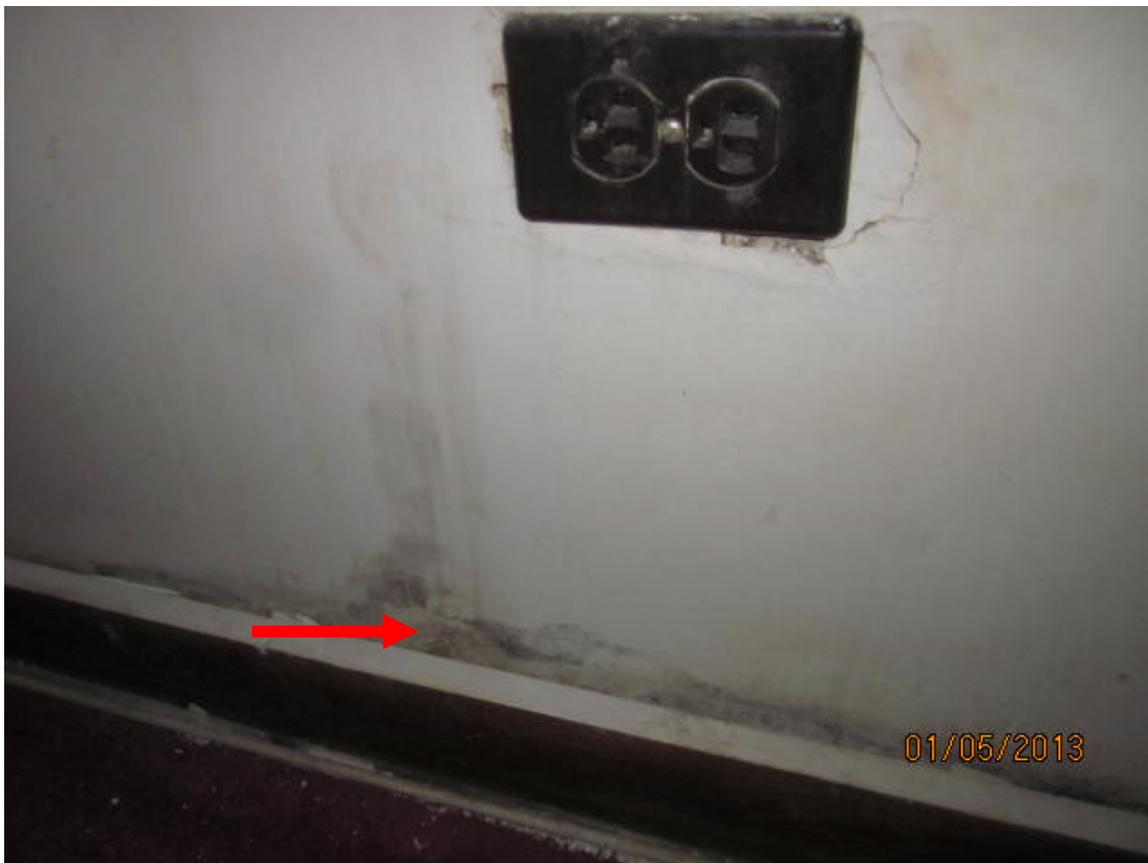
- There are signs of mold near the floor on the drywall in the basement wall north and also at the top level bedroom east wall. These areas were dry during my inspection. Moldy drywall should be thrown away. Consult the EPA regarding any concerns about mold or mold cleanup.

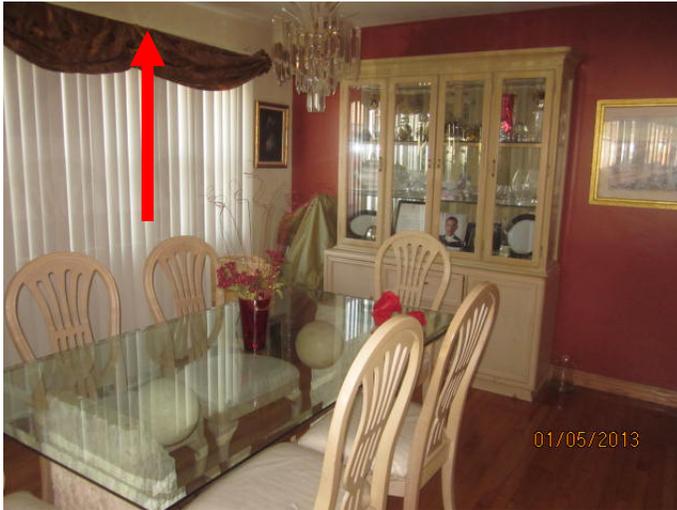
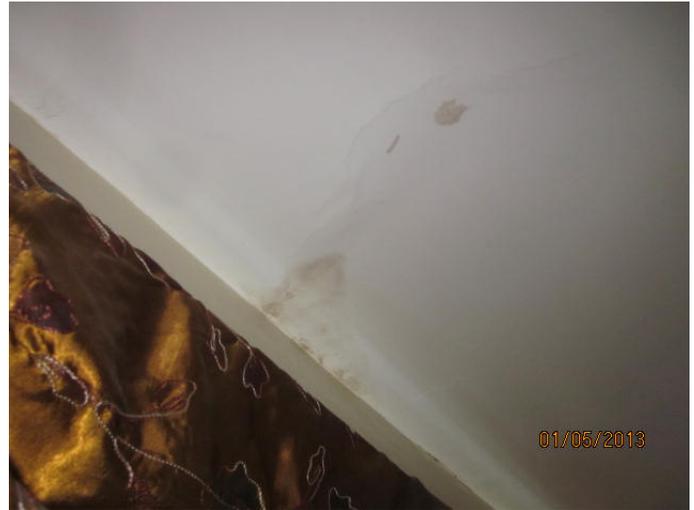
- There is ceiling damage and water stains at the ceiling in the dining room. This was dry during the inspection. I believe it is from an old roof leak which the seller claims.

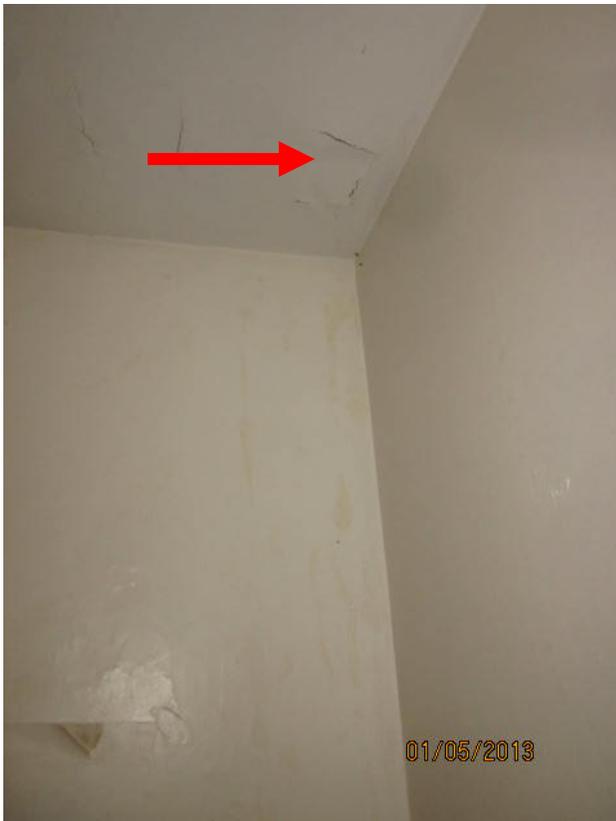
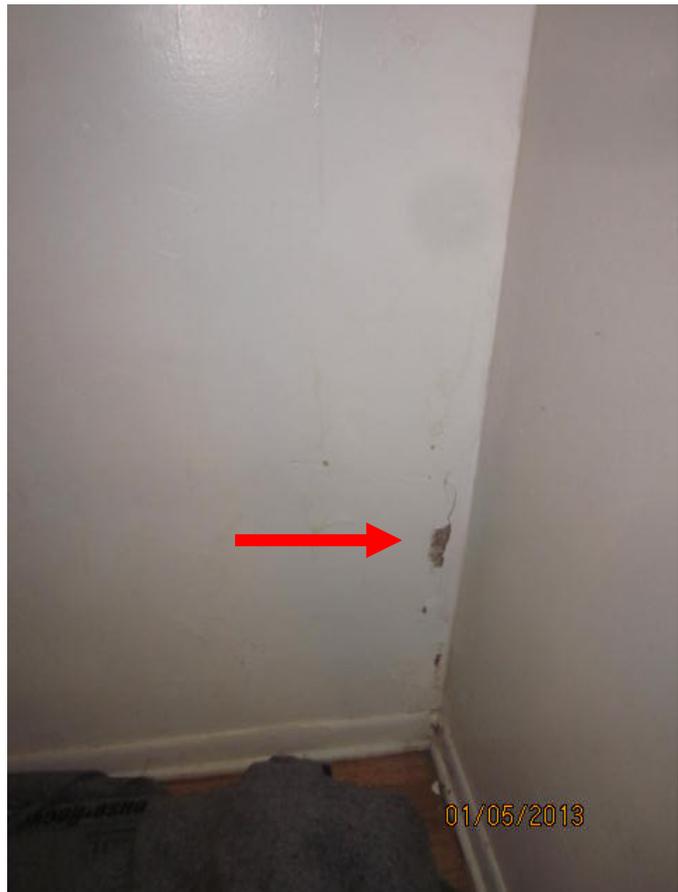
- The South bedrooms have bars on the windows which is an emergency egress hazard. They should be removed in case someone has to get out quickly in a fire.
- There are water stains and water damage to the ceiling and the wall in the Southeast bedroom. This was dry during the inspection and I believe it is from an old roof leak.

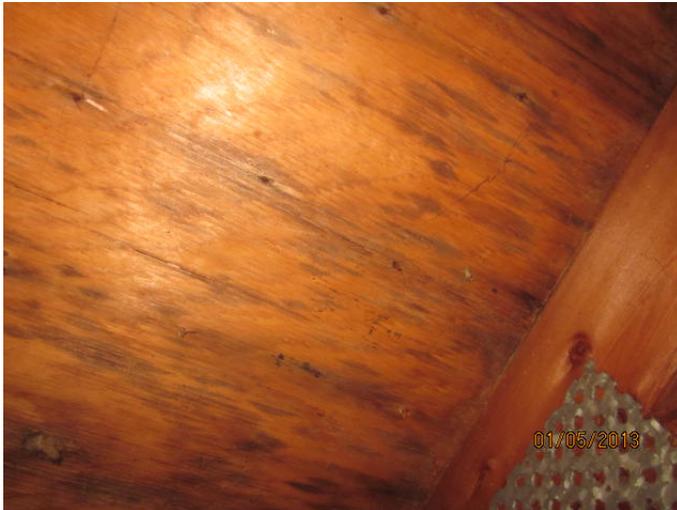
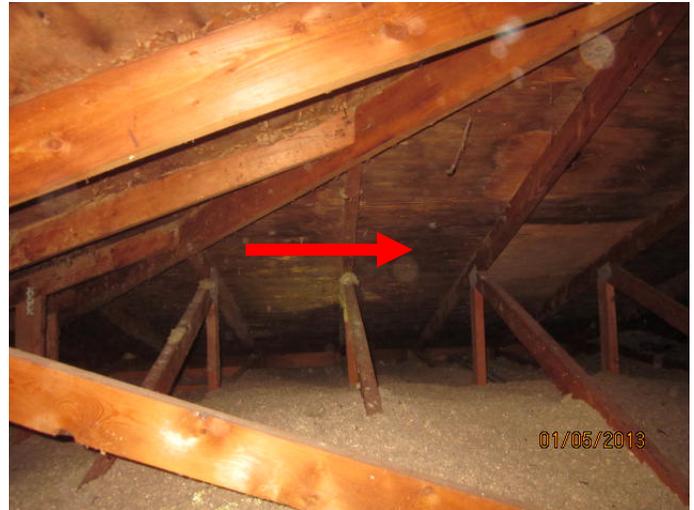
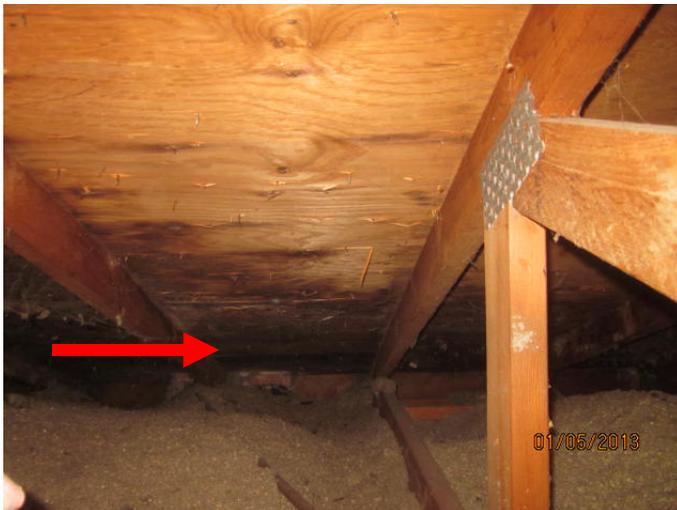
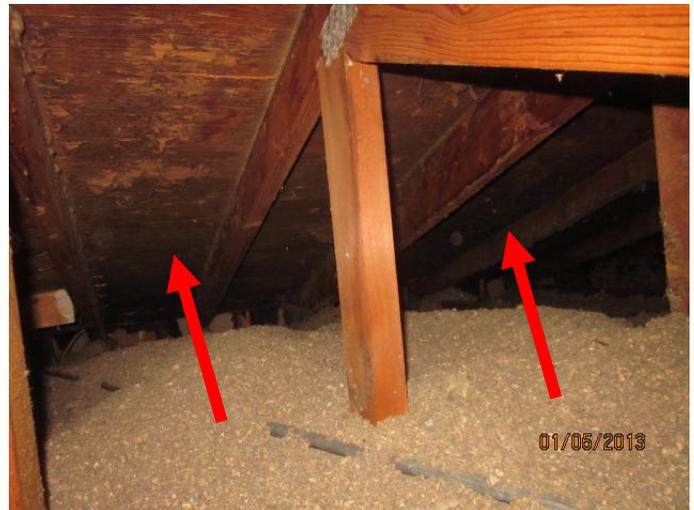
- I did not see any access hatch to the North attic.
- There are signs of mold in the South attic beneath the roof sheathing. There is also some delamination of the plywood roof sheathing caused by past moisture issues. Mold is caused by trapped moisture resulting from poor insulation and sealing of the attic floor, and lack of proper attic ventilation. New insulation has been added and there are roof louvers for ventilation so the issues I am seeing are probably from past problems. Consult the EPA regarding any mold concerns or cleanup.
