INSPECTION CONNECTION, INC.

DATE: 7/8/13

INSPECTION REPORT

252 S. HILL RD., PARK RIDGE, IL

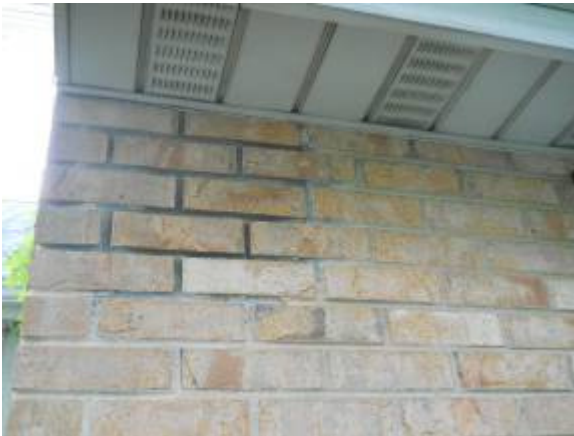
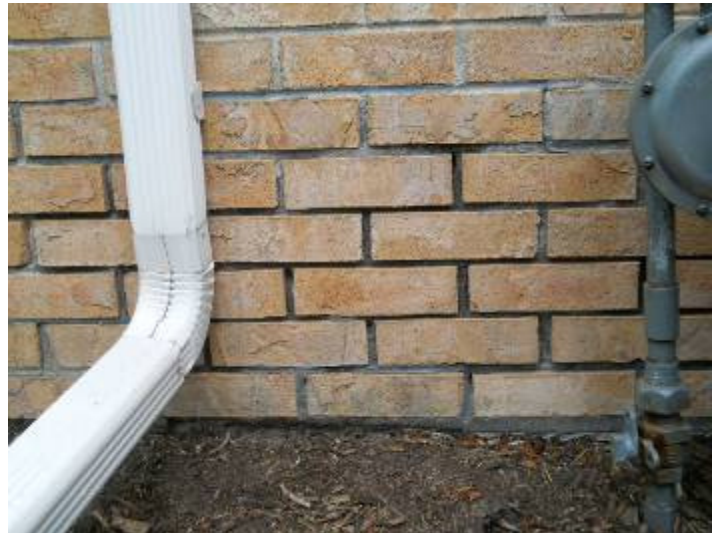
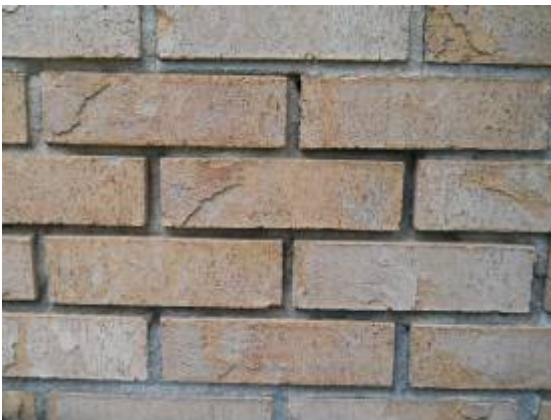
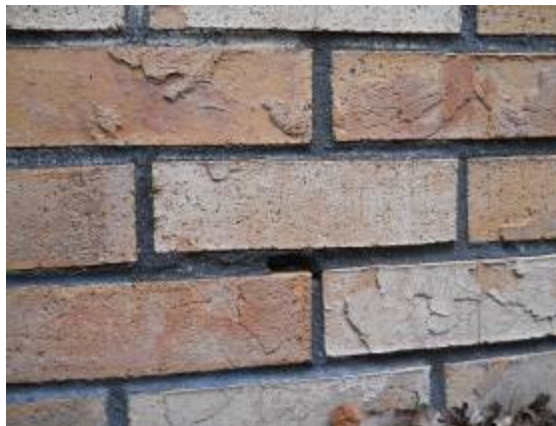
- The mortar between the outside wall brick needs re-pointing in many places. There are cracks, holes and deep recesses. You should consider having all of the brick mortar repointed to avoid cosmetic problems of matching old mortar with new.

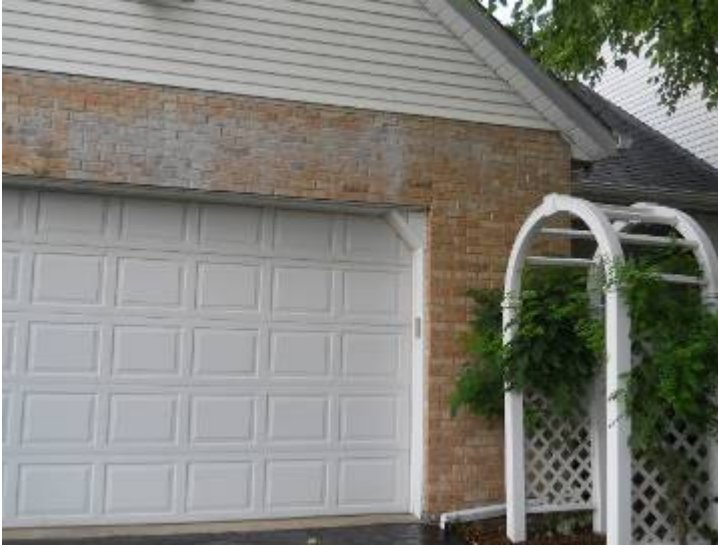
- There are white powdery marks at the brick above the garage door. This is probably from the old aluminum siding chalking and leaching downward. I do not know if this can be easily cleaned off.

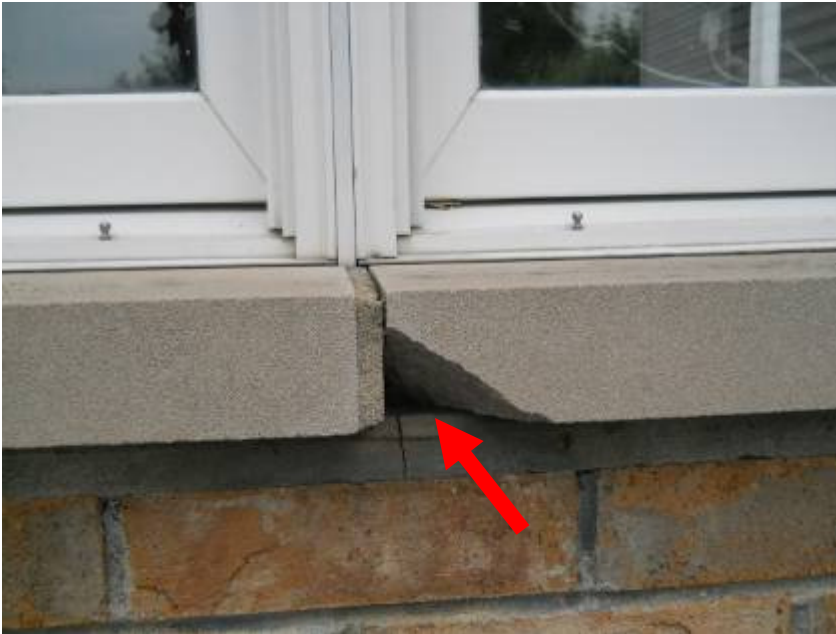
- The stone windowsill in back for the family room has cracked off at the lower corner. Have a mason repair this. There is water seepage in the basement beneath this area. Maybe this is to blame.

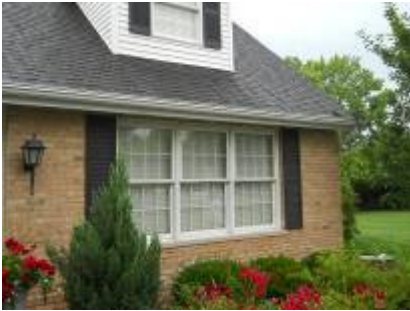
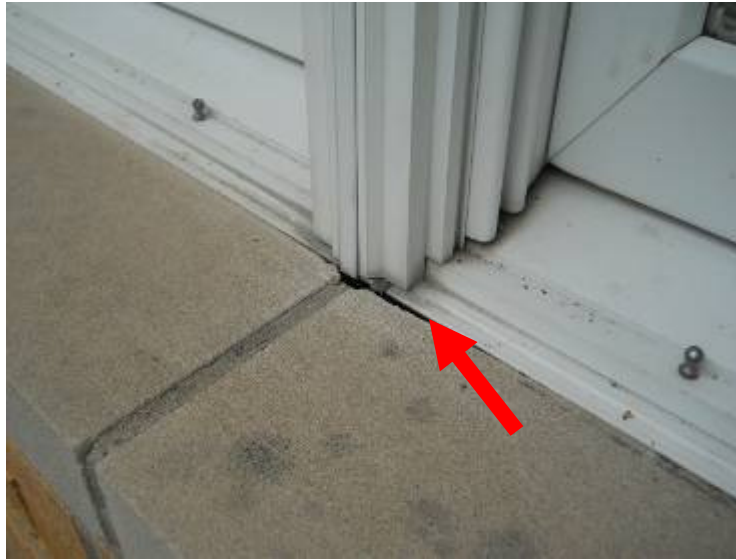
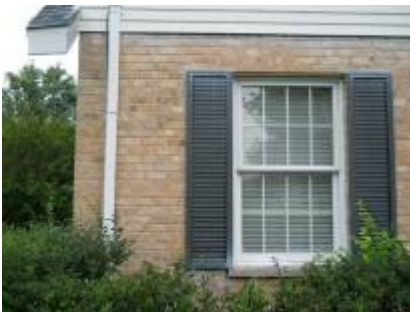
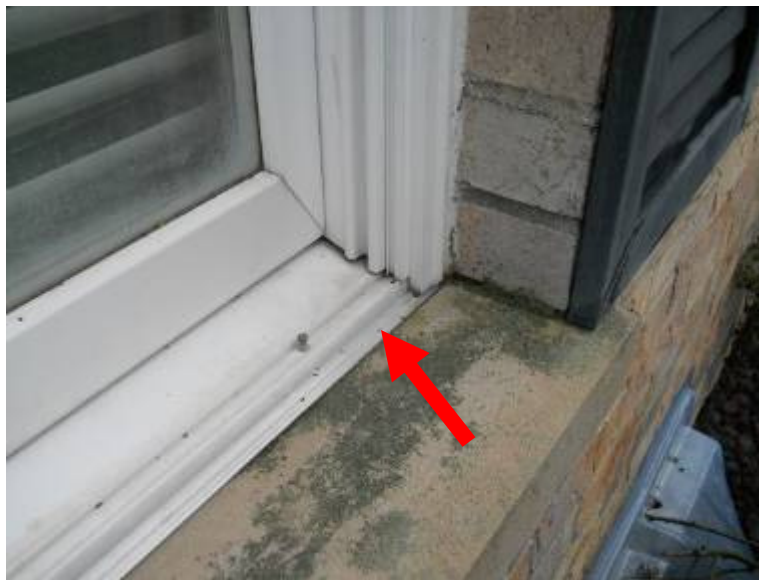
- The windows in front north and at the back north are poorly installed. They do not sit on the stone windowsill but behind it. Make sure these gaps stay caulked so water does not run into the wall.

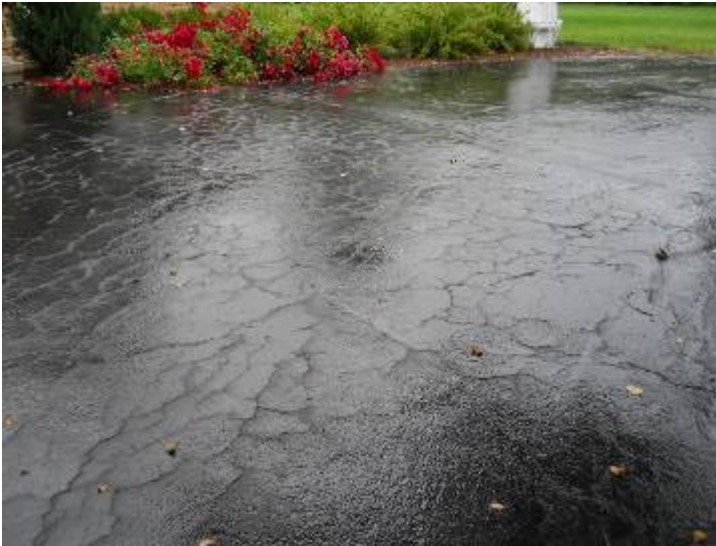
- The asphalt driveway has many cracks but no potholes as of yet. Seal any open cracks within asphalt filler caulk. There are a few that need maintenance.

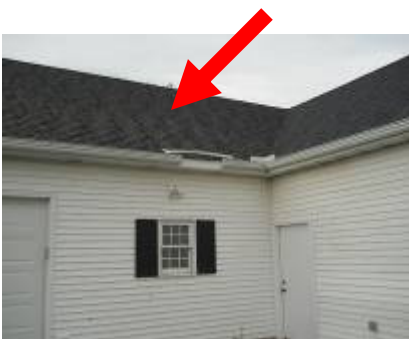
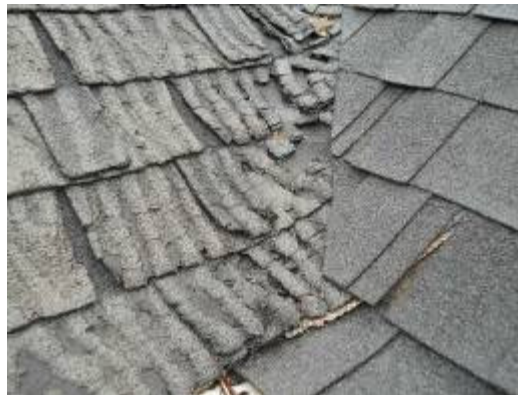
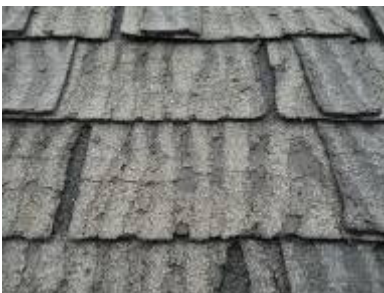
- The roof shingles over the south part of the garage have advanced deterioration and needs replacement. Consult a roofing professional.

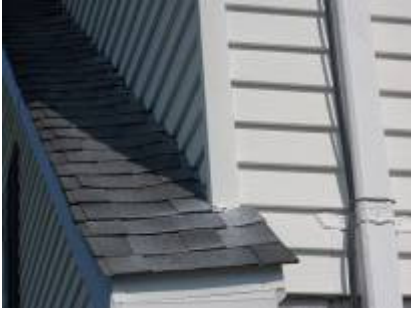
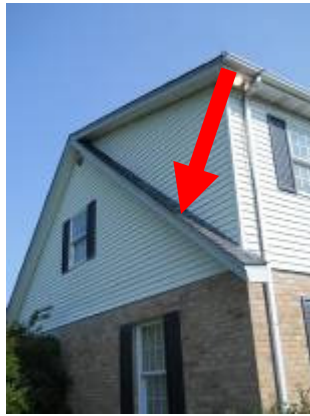
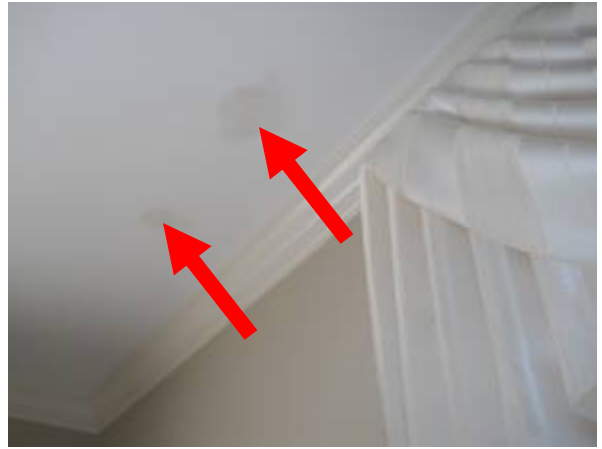
- There is an apparent roof leak at the area above the northwest dining room. The ceiling is wet. It is likely that this is a step or counter flashing problem and exterior siding will need to be removed to fix this. Consult a roofing professional.

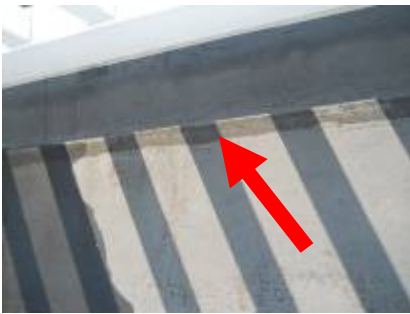
- A seam on the flat roof above the sun room needs maintenance. Otherwise, this roof (EPDM) looks satisfactory.

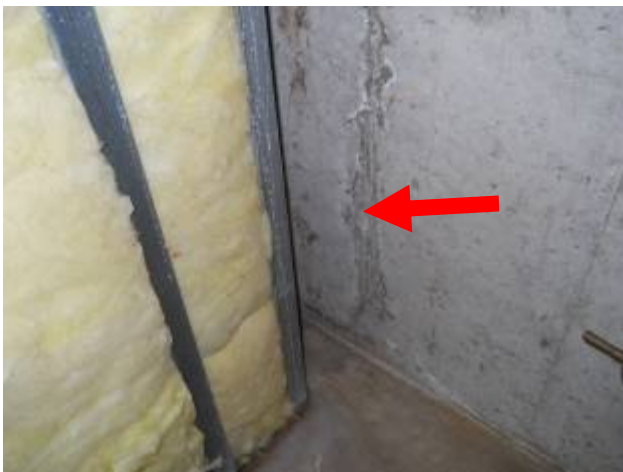
- The handrail for the basement stairs should extend all the way down to the bottom step. The wide gaps at the stair side guard are a fall hazard for small children.
- There is a crack in the foundation at the west wall in the furnace room that looks like it has had seepage. Consult a waterproofer.

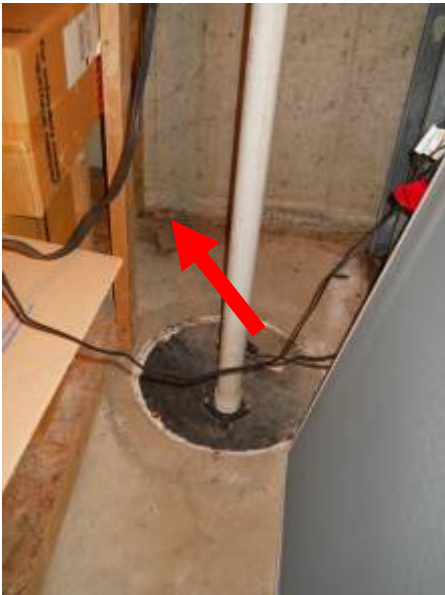
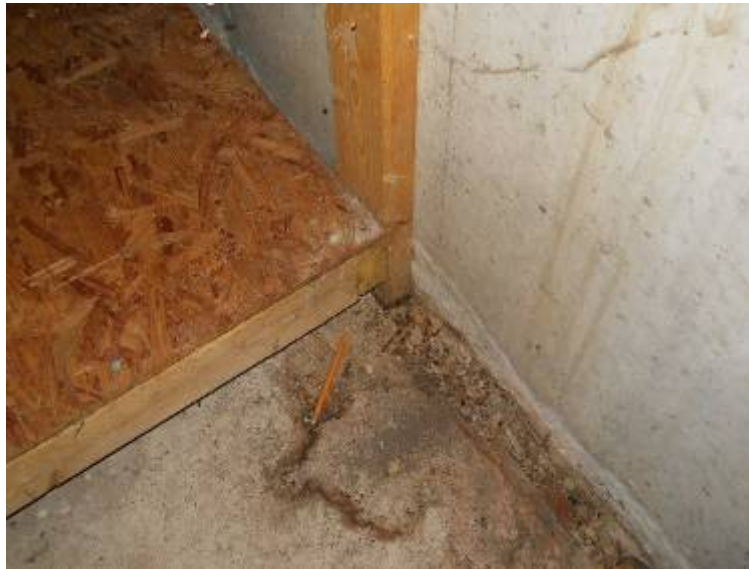
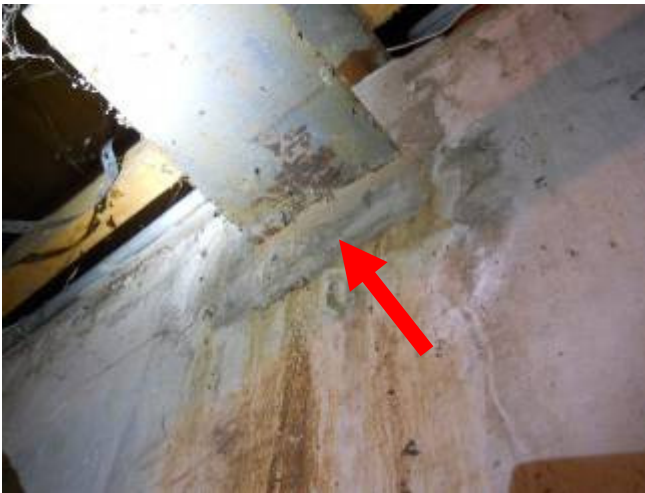
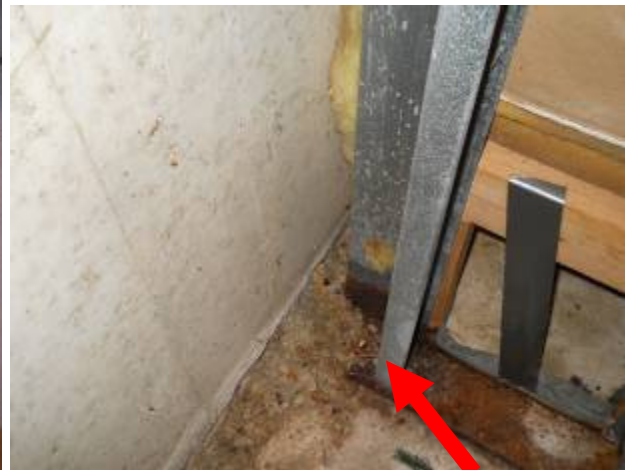
- There is seepage in the basement on the west side above the ejector pit that looks like it is coming from beneath the beam pocket. There is a window outside with a broken stone sill and a large gap beneath it that might be causing this problem. You will need to investigate this further and consult a waterproofing professional or a mason.

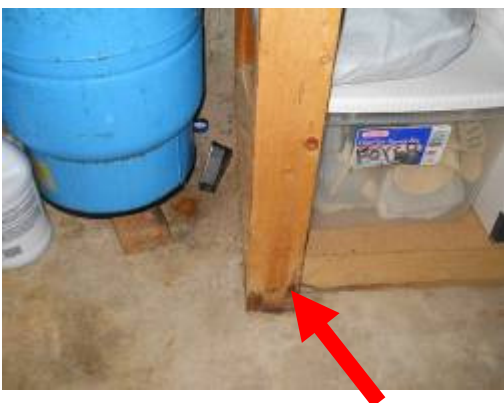
- The floor near the water softener in the basement is wet. This maybe from condensation.

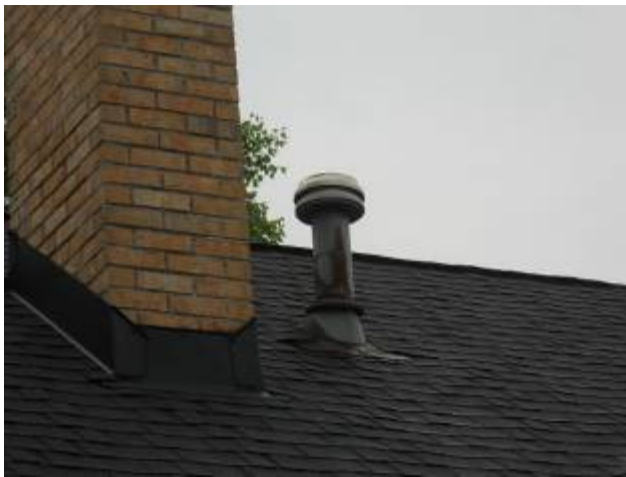
- There is a gas space heater in the garage which is functional. The B vent termination on the roof should be at least 8 feet away from any walls or obstructions. It is improperly located a couple feet from the chimney. The exterior vent is rusting. Consult a licensed HVAC professional.

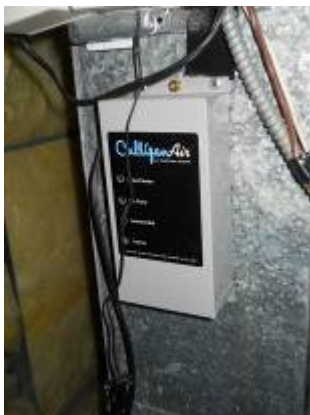
- Besides an electronic filter, both furnaces have a UV light filter system. I do not know if these are working or not. Have them service by a licensed HVAC professional.

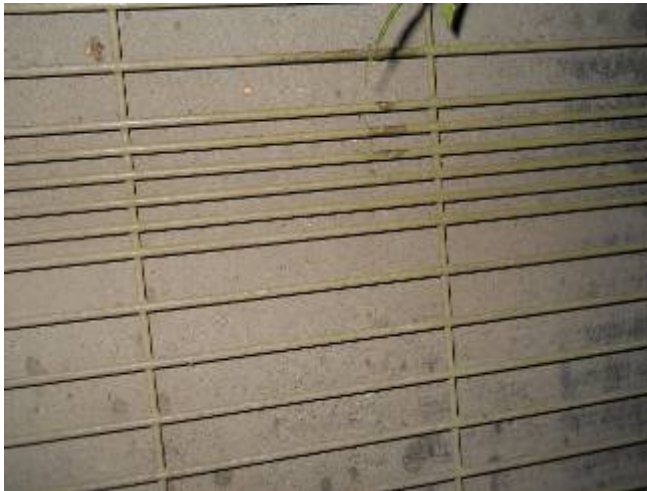
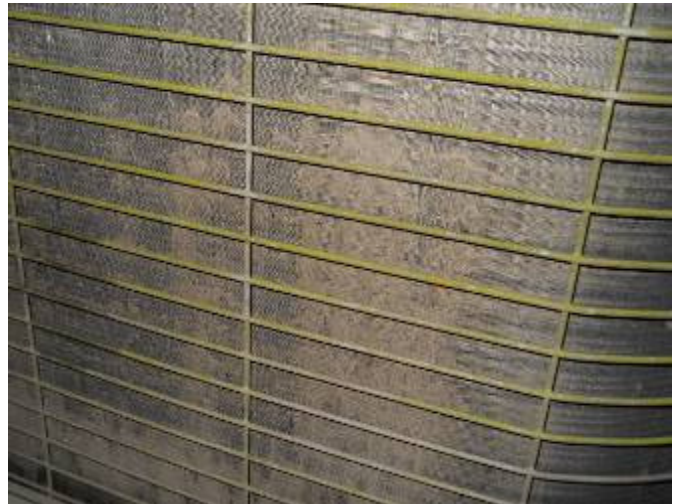
- Both air-conditioning compressor units were cooling during the inspection.
- The cooling fins at both outside compressor units are dirty and need cleaning.

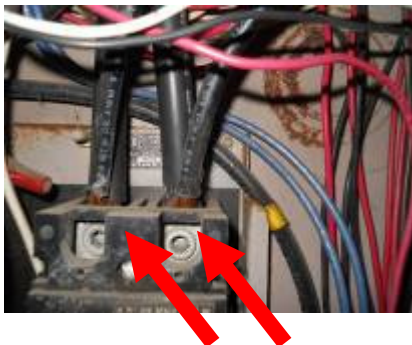
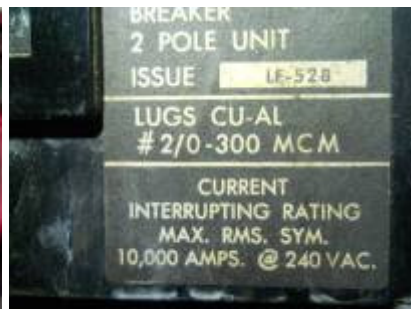
- The lugs for the main circuit breaker have been improperly double tapped. Consult a licensed electrician to correct this.

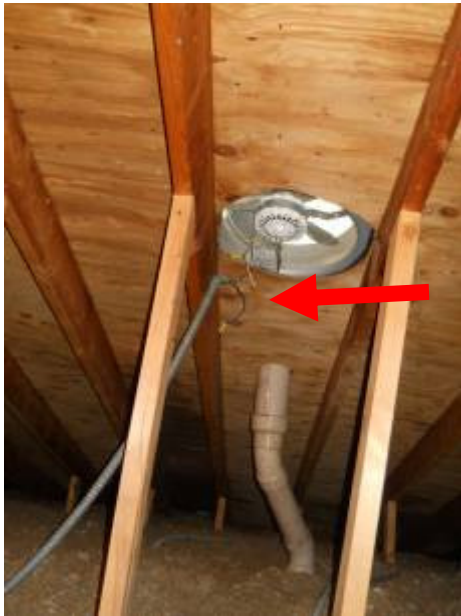
- A GFCI should be installed outside on the sun deck.
- There are exposed wires supplying power to the attic fan. Have a licensed electrician properly secure this raceway.

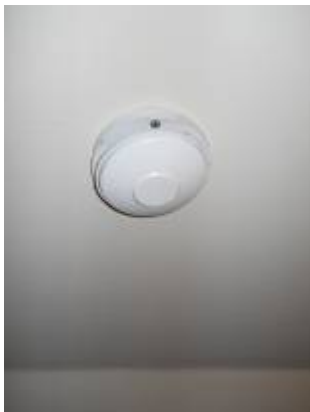
- There are a lot of devices on the ceilings throughout the house that look like smoke detectors. I do not know if they are functional. Smoke detectors generally need to be replaced every 10 years or less.

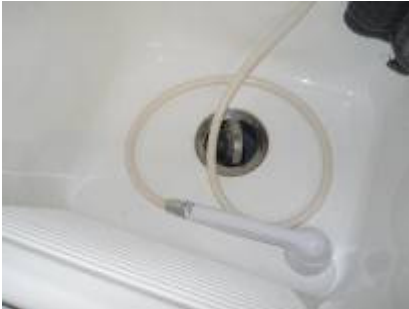
- The basement sump pit has been enclosed in a wooden box. I could hear the pump operating. There is a battery operated backup sump pump system. I do not inspect these.
- Homes with sump pumps are at risk of flooding if the primary pump fails. I recommend a back-up sump pump system be used. Will the seller leave the one that is here?
- There is a gas pipe against the west basement wall in the furnace room that should be secured to the wall.
- Hoses left in sinks can back siphon dirty water into your drinking water.

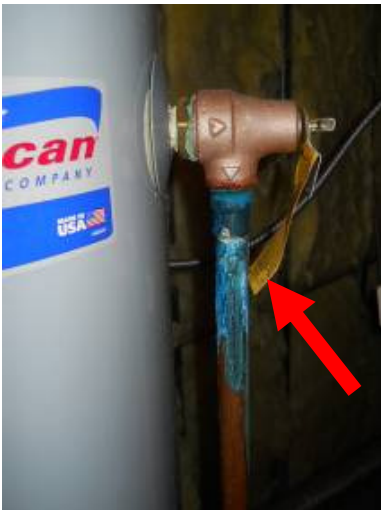
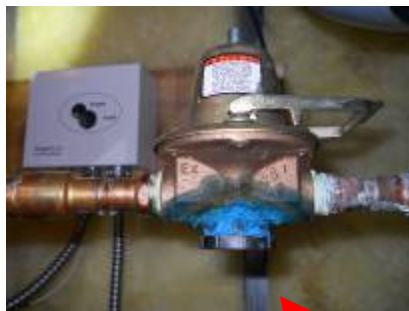
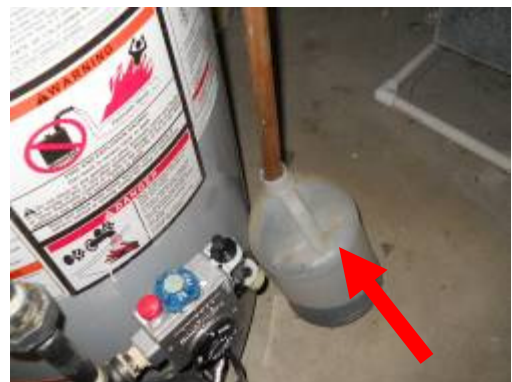
- It looks like the temperature pressure relief valve for the east water heater is dripping into a bucket. If it is leaking it should be replaced. Consult a licensed plumber.

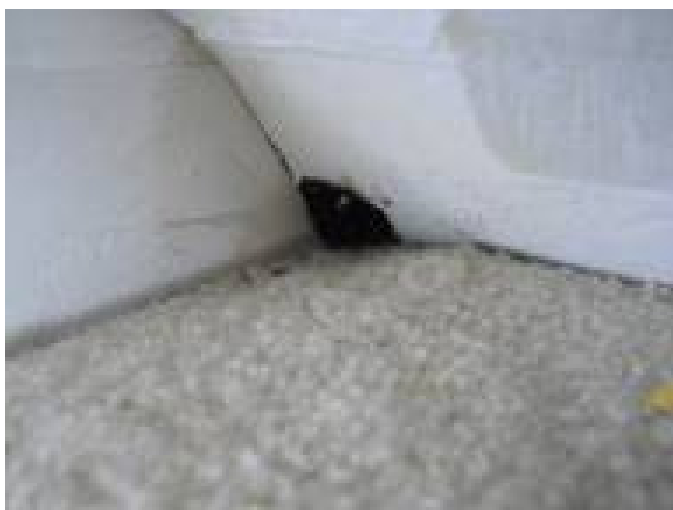
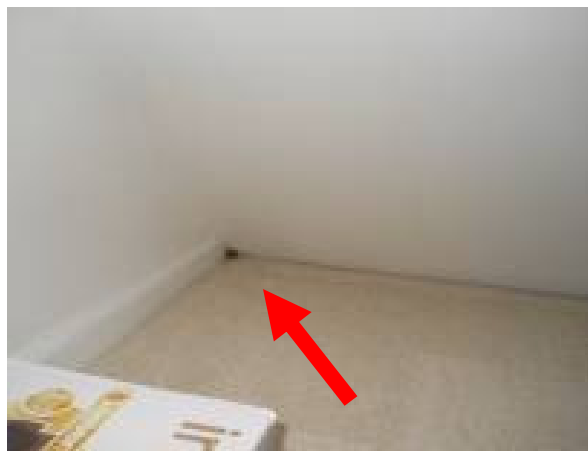
- There are water stains at the dining room ceiling near the north wall. This is apparently from a roof leak.
- There are mousetraps at several places within the house and garage. There is a hole in the closet wall near the floor of the southeast bedroom with mouse feces nearby. Consult a pest problem.

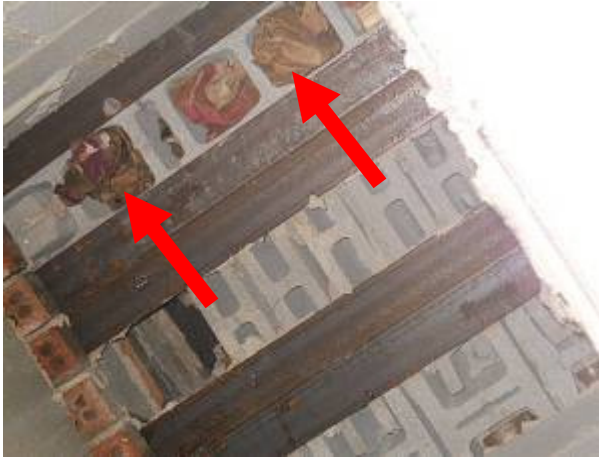
- I took a picture from the basement clean-out to the area beneath the fireplace. It looks like wads of paper have been stuffed into the CMU cavities. Combustible materials should not be left at the underside of fireplaces. Consult a licensed chimney sweep.

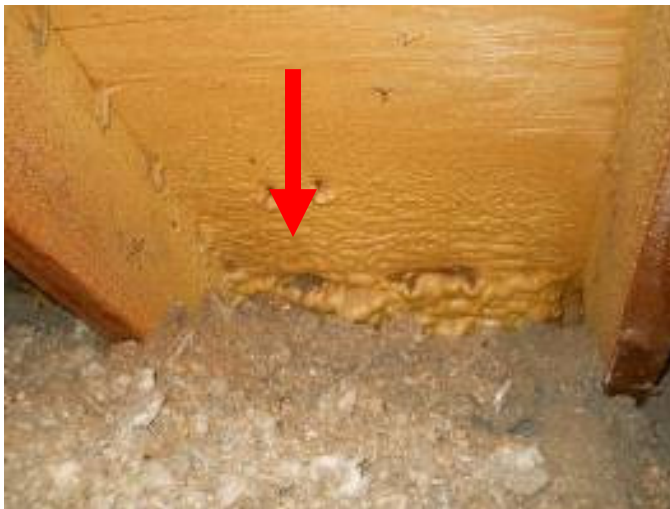
- There are water stains on the wall in the garage attic at a light fixture junction box on the east side. It was dry so it appears this leak has been fixed.
- There is a whole house fan in the wall of the master bedroom closet. This is a poor location. Also, these fans need a great deal of attic/roof ventilation to operate properly. The attic ventilation in this area looks inadequate. Consult the manufacturer's instructions. Never operate this fan without windows and doors in the house open because it creates tremendous negative pressure within the home.
- Expandable foam has been sprayed between the rafters on the east side of the upper attic. This will block any soffit venting on that side of the house. This form should be removed.

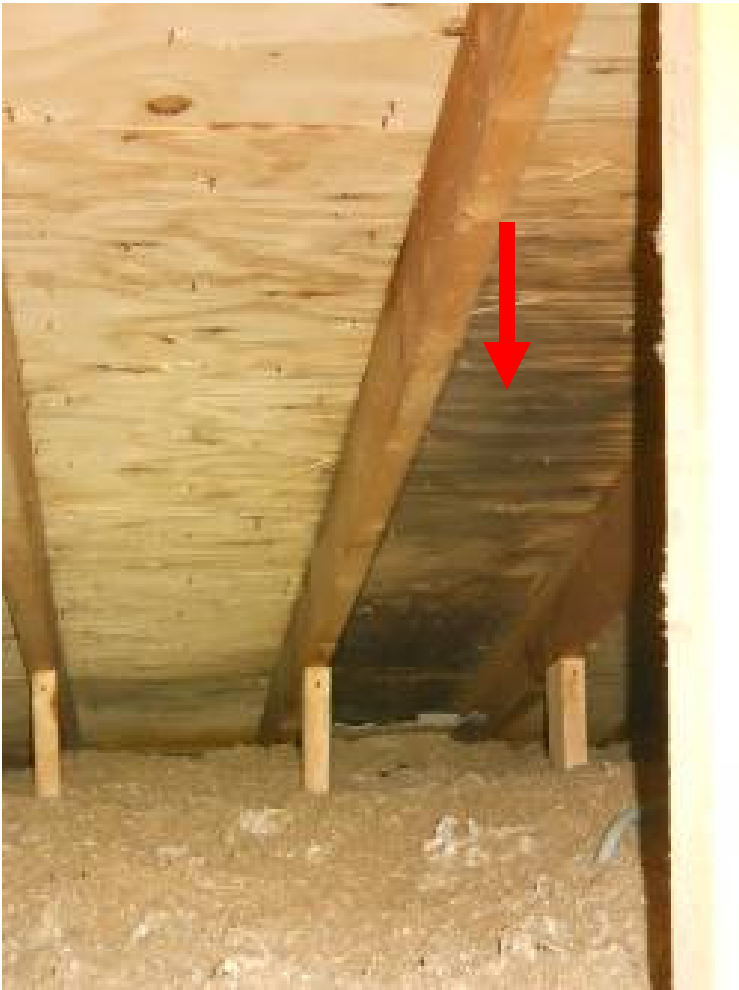
- There looks like a lot of moisture and mold between a couple of the rafters on the west side of the attic. This is most likely being caused by a poorly vented bathroom fan. The exhausted bathroom fans need to be vented outside. Someone will need to crawl in closer to see if they can fix this problem. Consult the EPA regarding any mold concerns.
