INSPECTION CONNECTION, INC.

ADDRESS: 4 ELM

SAMPLE INSPECTION REPORT

4 ELM, SAMPLE, IL

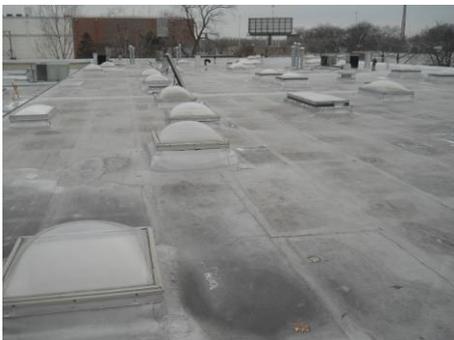
- Many areas of the interior steel roof sheathing are rusted. The roof looked newer and these are probably from old roof leaks.
- This building has two different roof systems. There is a raised roof along the north side of the building which is above the second-floor apartment units. And there is a second lower roof area to the south which is above the warehouse portions of the building

- There is ponding at the upper east roof which had about an inch and a half of ice. This ponding will accelerate roof deterioration.

- There is a roof and/or parapet wall leak at the lower roof east side at the warehouse section of the building. A licensed roofing professional should address this.
